**Southwest Interceptor
Local Sewer System Evaluation Study
(SWI-LSSES)**

**City of Berea
Community Report**

February 2022

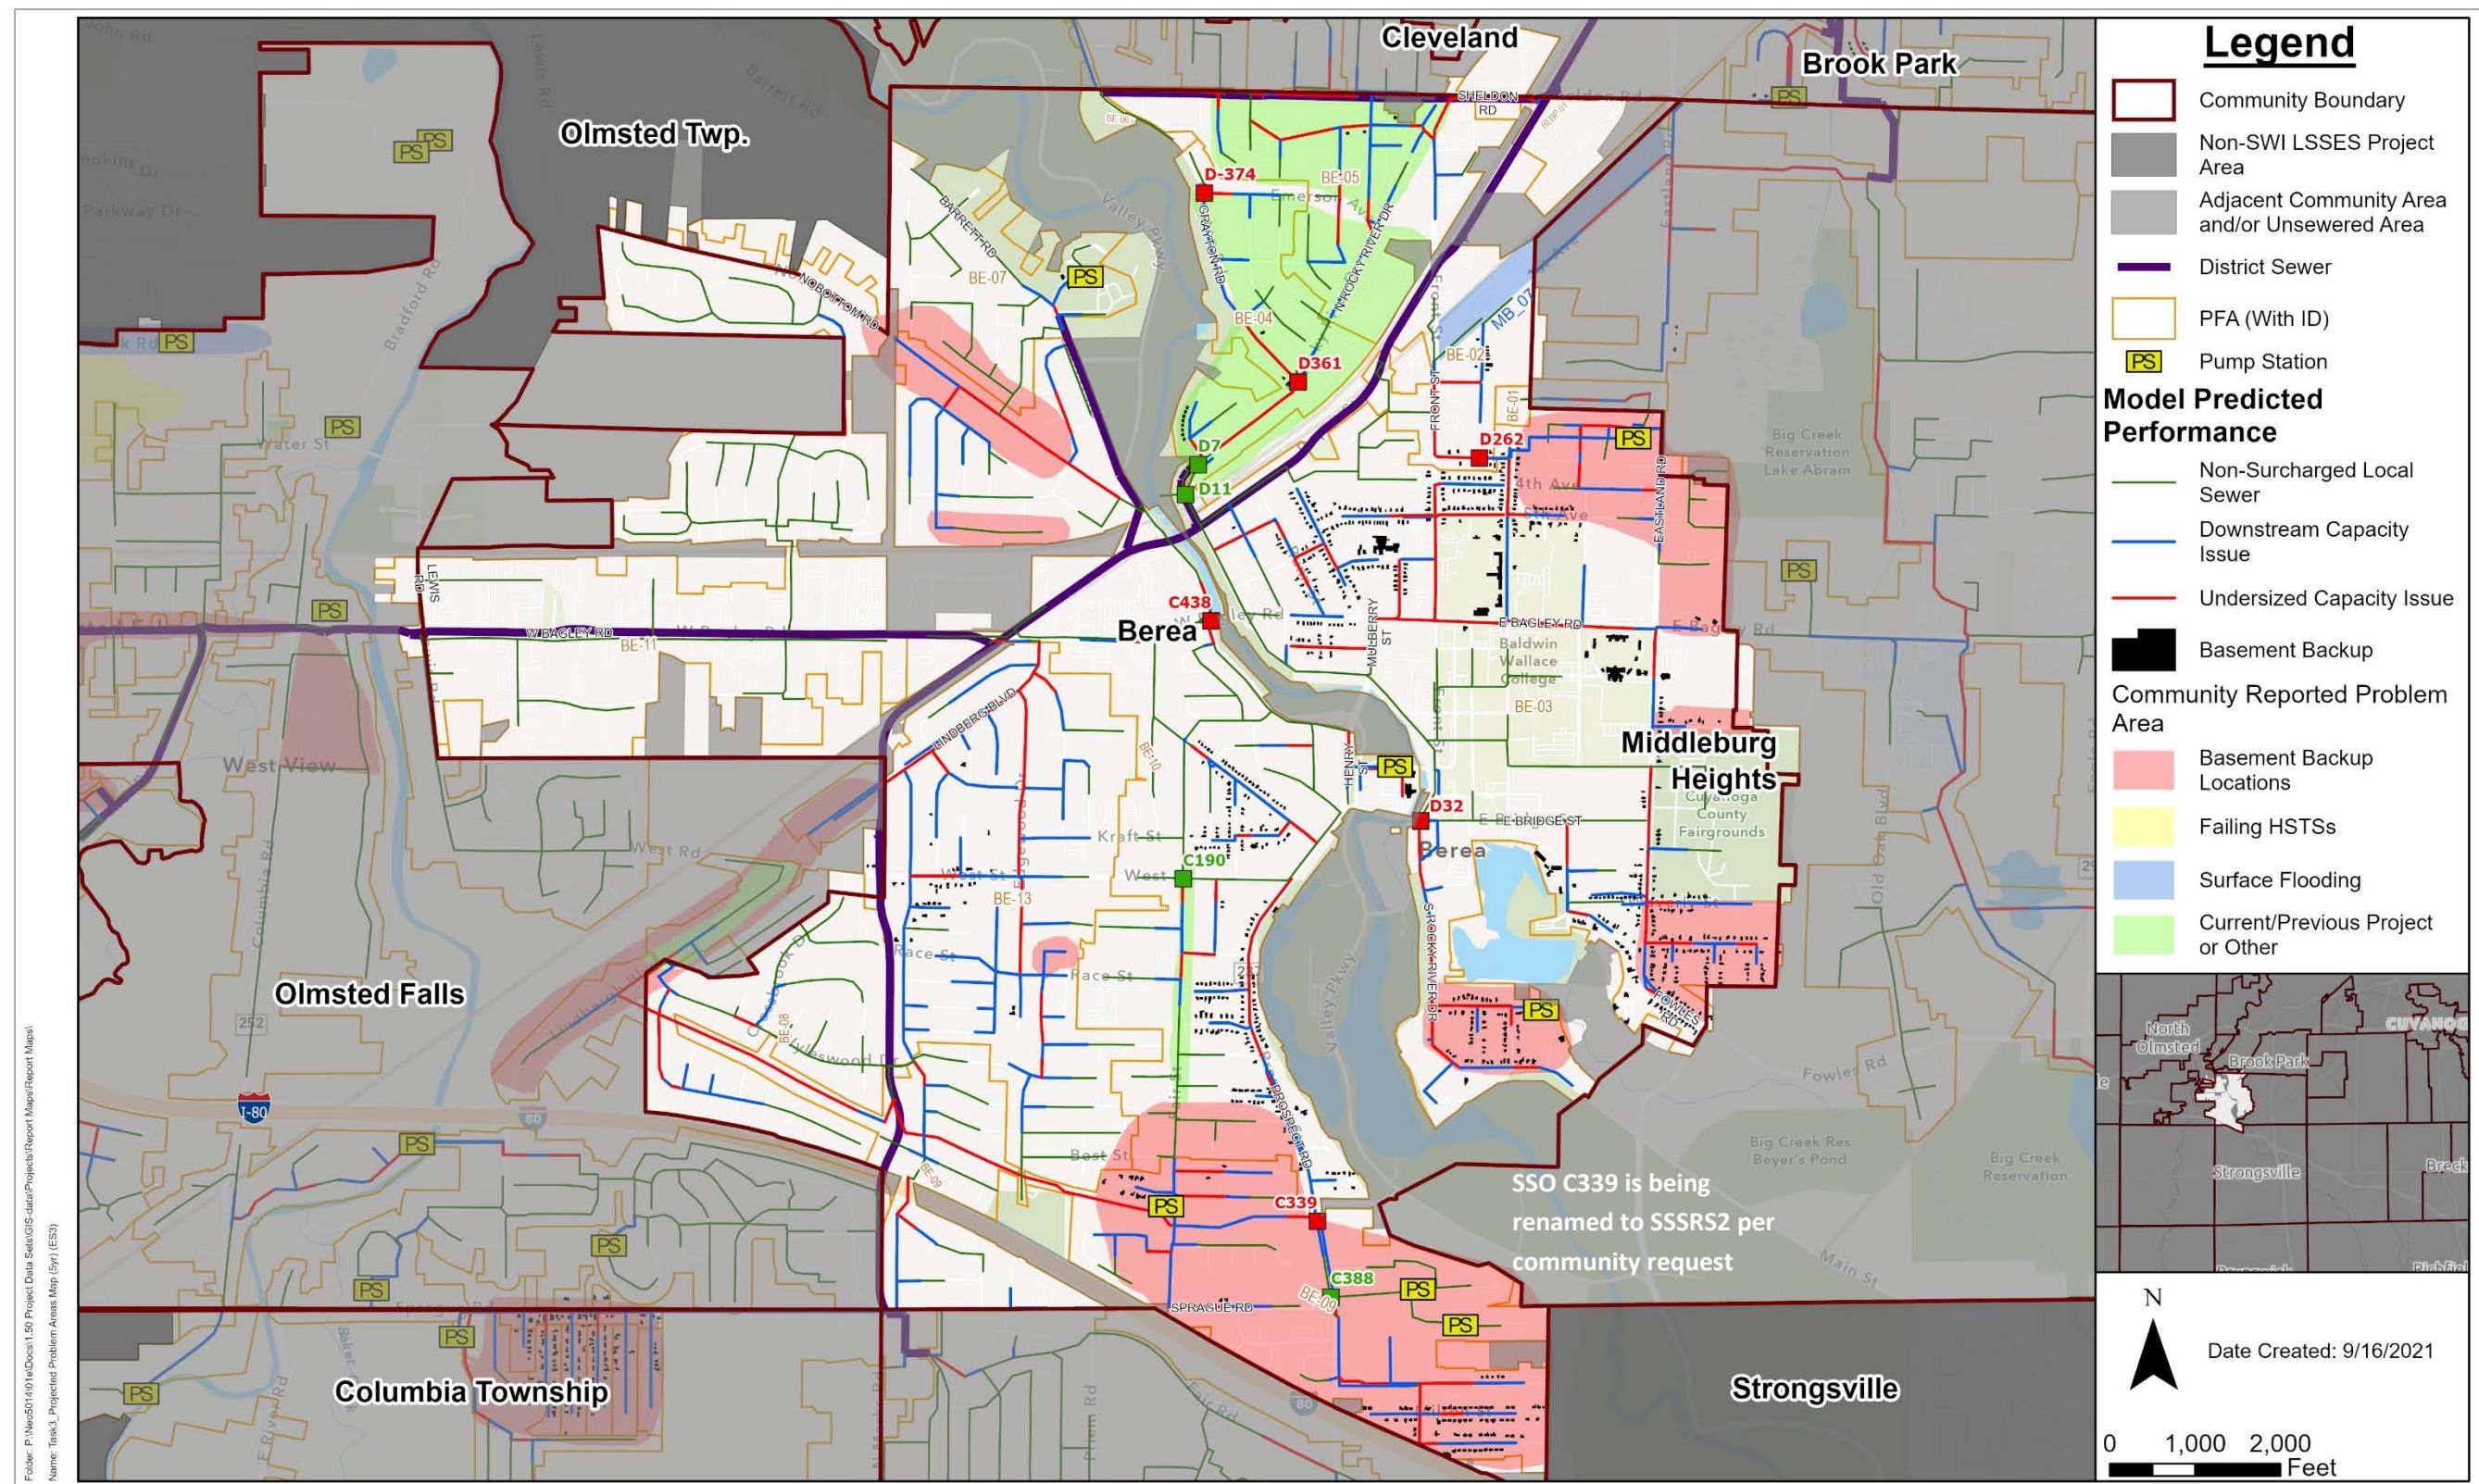
Figure ES-4. Reported and Projected Problem Areas (5-Year, 1-Hour Rainfall)

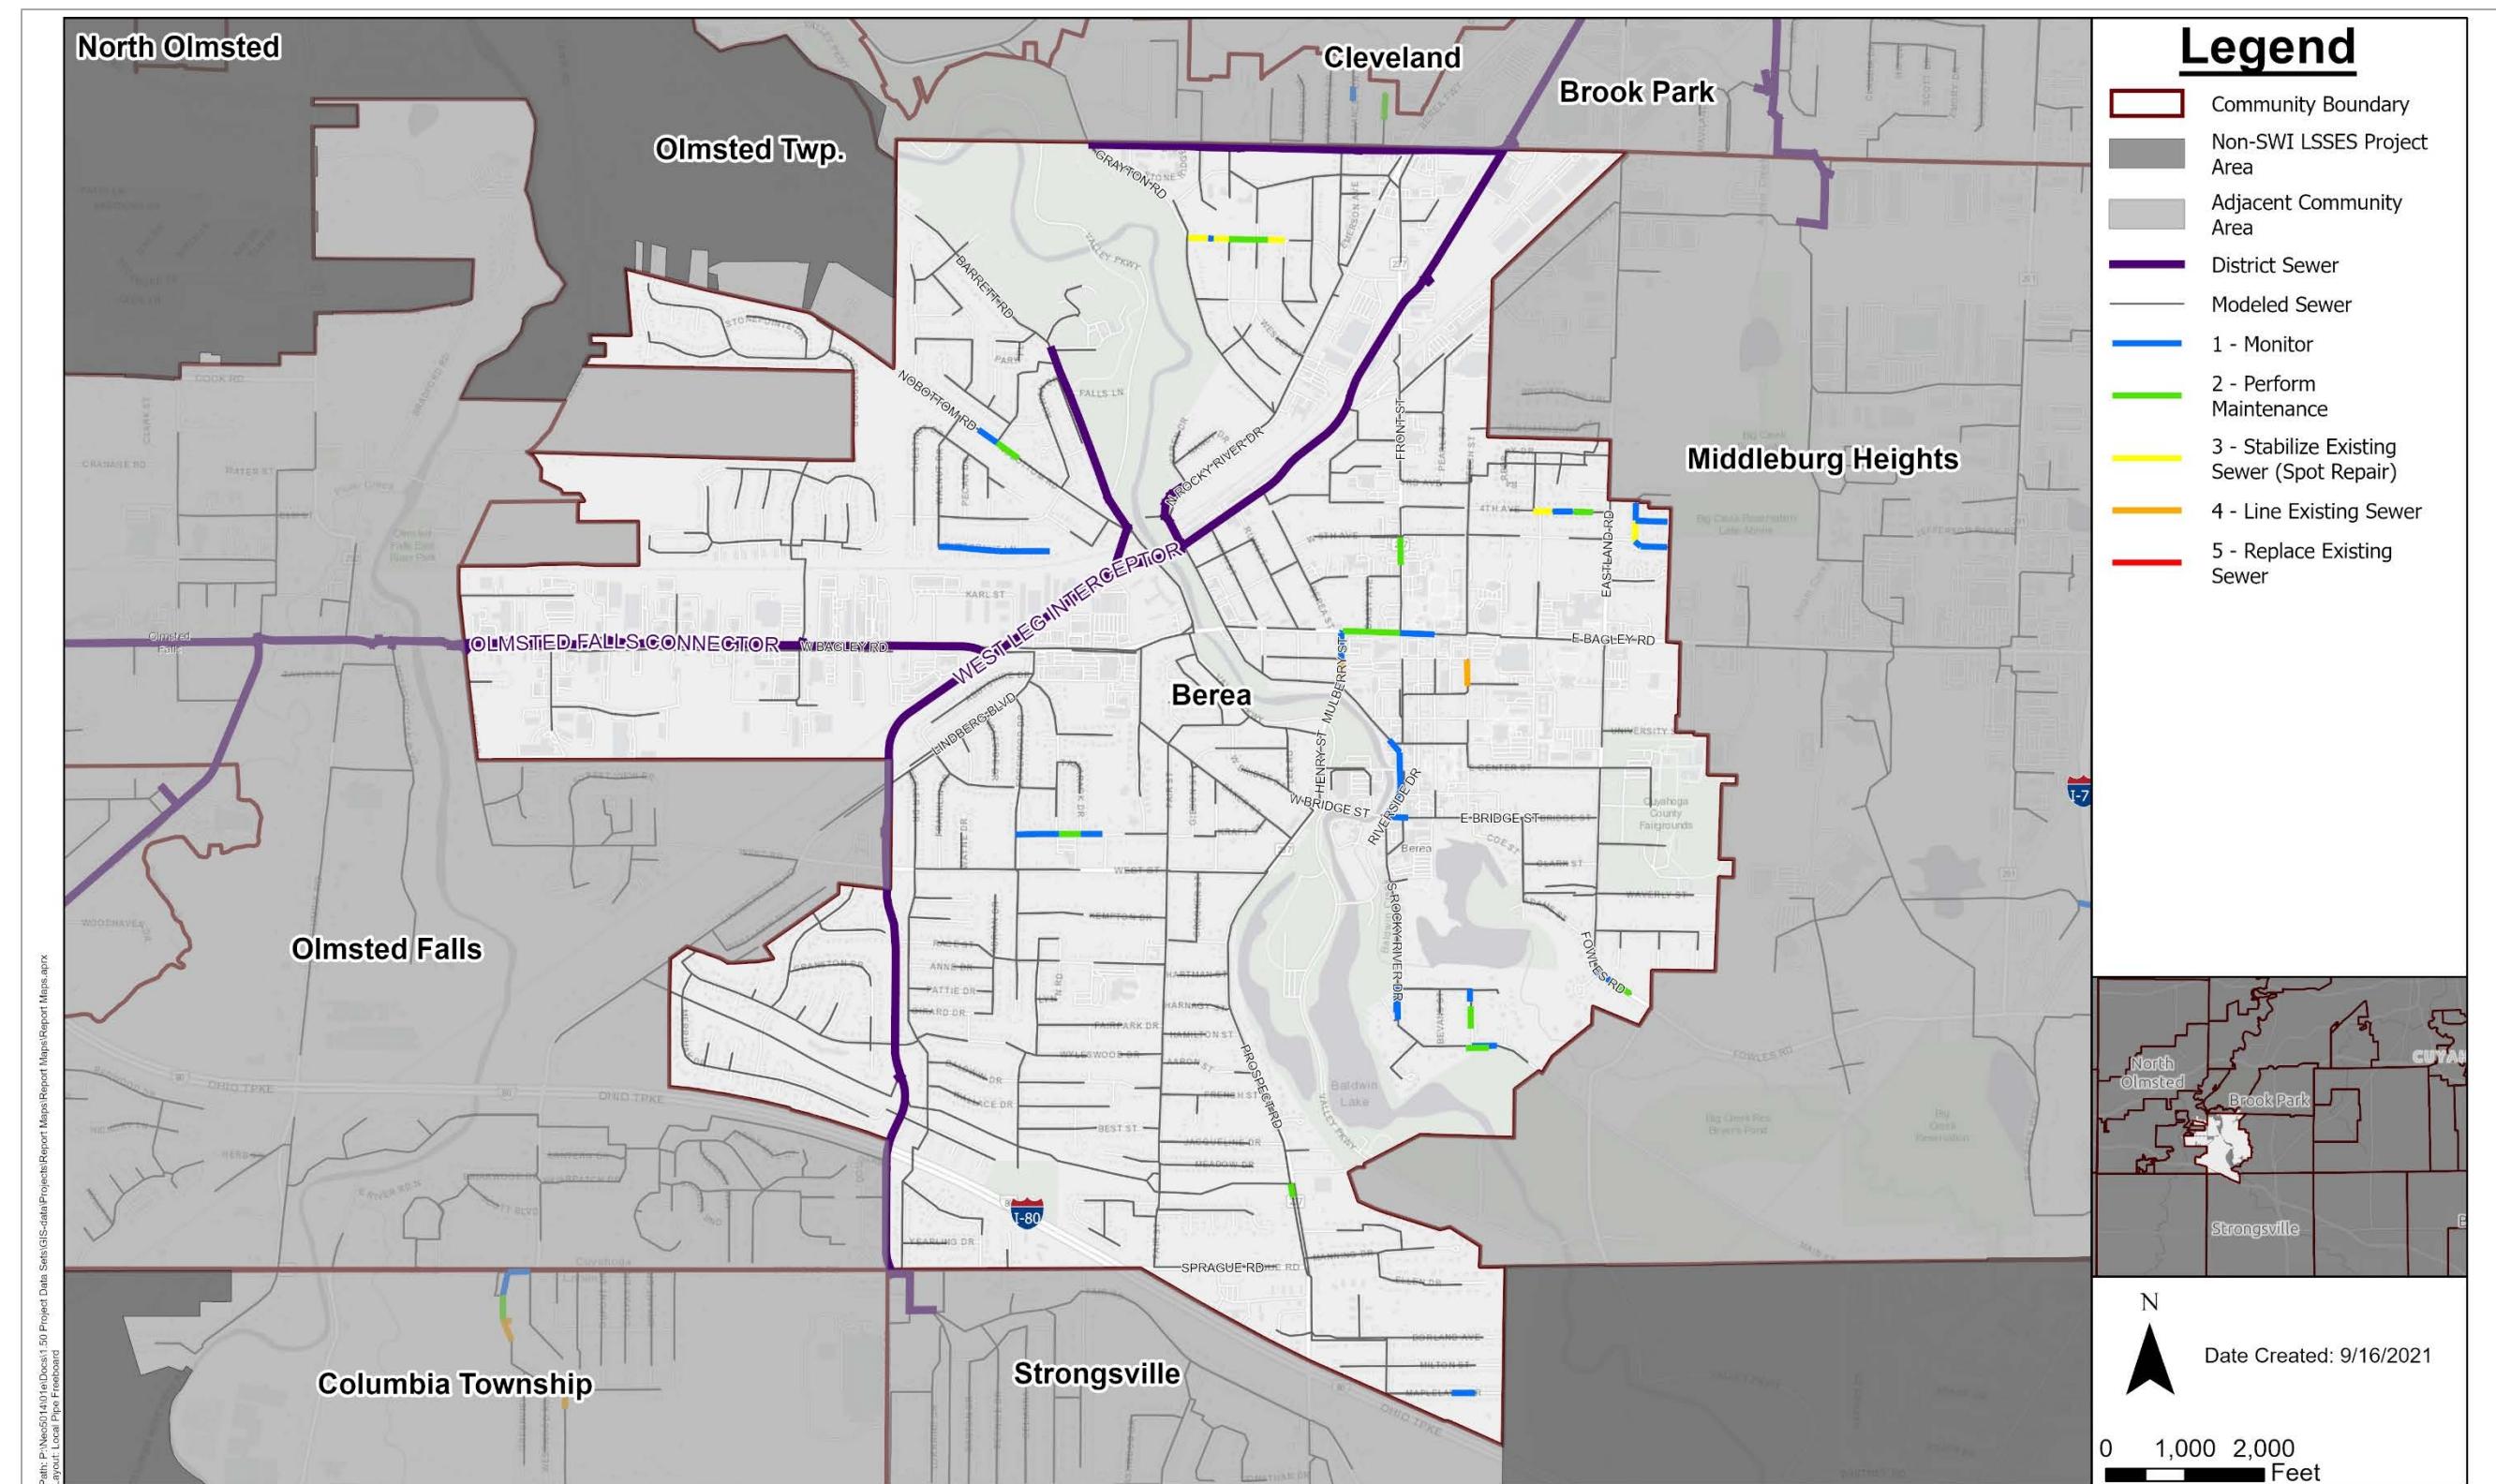
Field investigations conducted include closed-circuit television (CCTV) inspection of selected sewers in prioritized field work order areas. The results and recommended sewer rehabilitation levels were detailed in a technical memorandum provided to the District and communities entitled, *1485 Southwest Interceptor - Local Sanitary Sewer Evaluation Study (SWI-LSSES) Task 2 – Local System Inspection and Condition Assessment, July 2021*. This memorandum included pipe condition assessments based on NASSCO³ guidelines and associated typical recommended rehabilitation levels based on the assessment.

The suggested rehabilitation levels are summarized in **Figure ES-6** and are also available on the District's ArcGIS Online (AGOL) website. The condition assessment of Berea sewers was limited and when planning for future system improvement and/or rehabilitation projects, both the condition assessment information and the overall performance improvements described subsequently in this community report should be considered and re-assessed in planning and design phases of those improvements. **Figure A3 in Appendix A** summarizes the field investigations and findings that support the recommended rehabilitation levels

Figure ES-6. Summary of Sewer Rehabilitation Recommendation Levels Based on Project CCTV Inspection

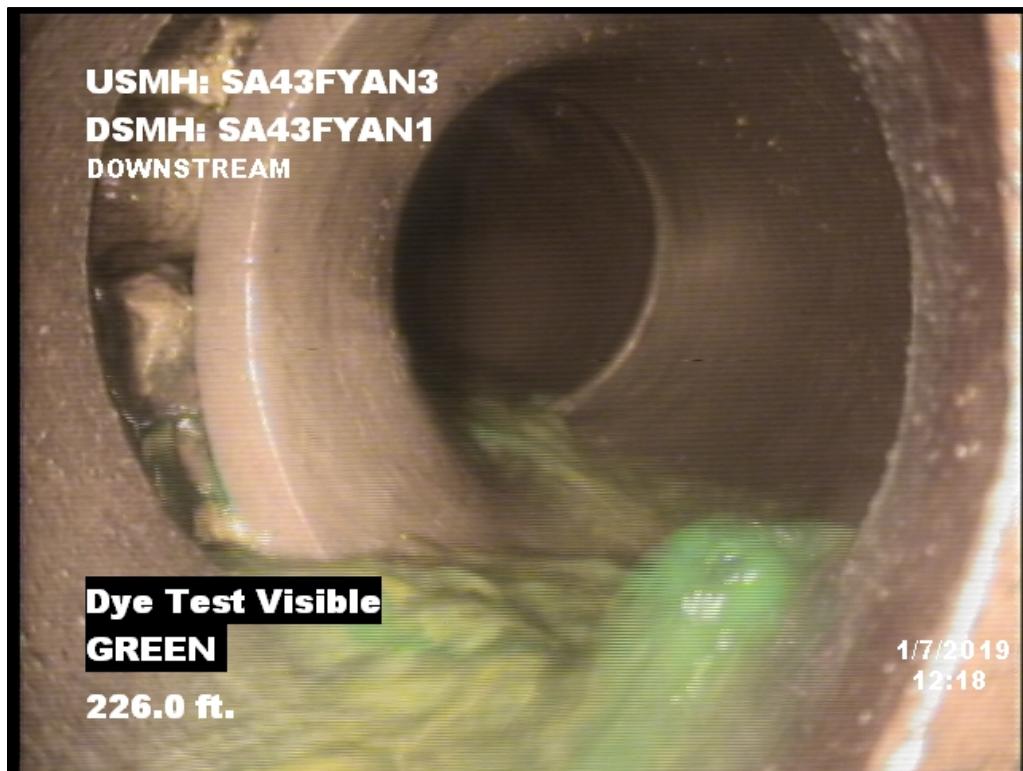
Figure 3-4. Infiltration from Storm Sewer to Mainline Sewer at Sanitary Service Lateral

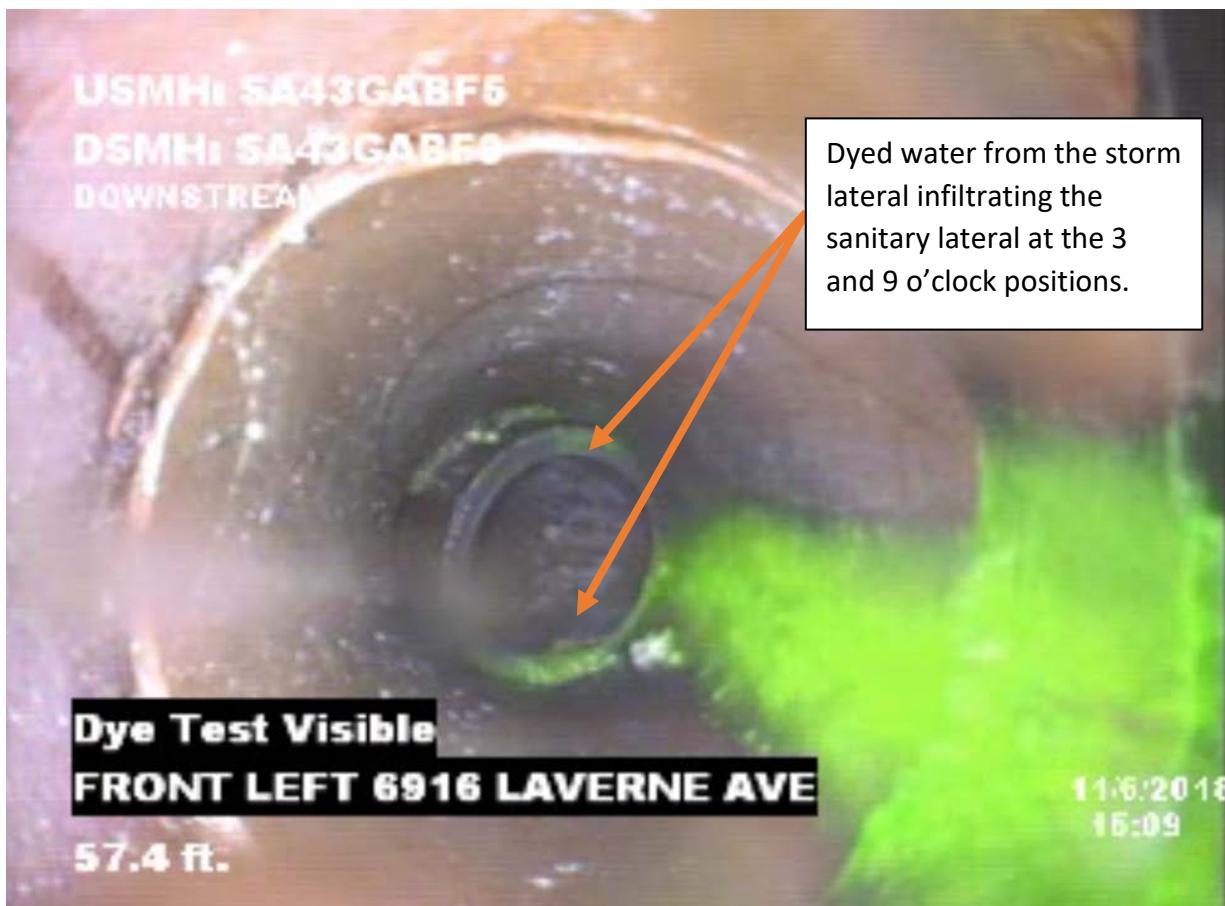
Figure 3-9 shows an example of rapid response observed in the sanitary lateral during private property investigations. Dyed water introduced to the stormwater lateral via the downspout can be seen infiltrating the sanitary lateral at the visible joint at the 3 o'clock and 9 o'clock positions. Note that there is no direct connection from the stormwater lateral system. When the dyed water entry point was visible, a defect, rather than a direct connection, was indicated to be the source of the infiltration.

Locating leaks from the private stormwater lateral to the private sanitary lateral may require progressive investigation. When the dye entry point into the sanitary sewer can be located, point repairs may be suitable to address the observed leak. As an example, in the photo shown in **Figure 3-9**, all the downspouts had a rapid response to the sanitary sewer. In this case, the camera was able to capture that all the positive tests entered the sanitary lateral at the same defect. However, as explained in the following paragraph, additional leaks may also exist.

Figure 3-9. Downspout Water Infiltration into Sanitary Lateral

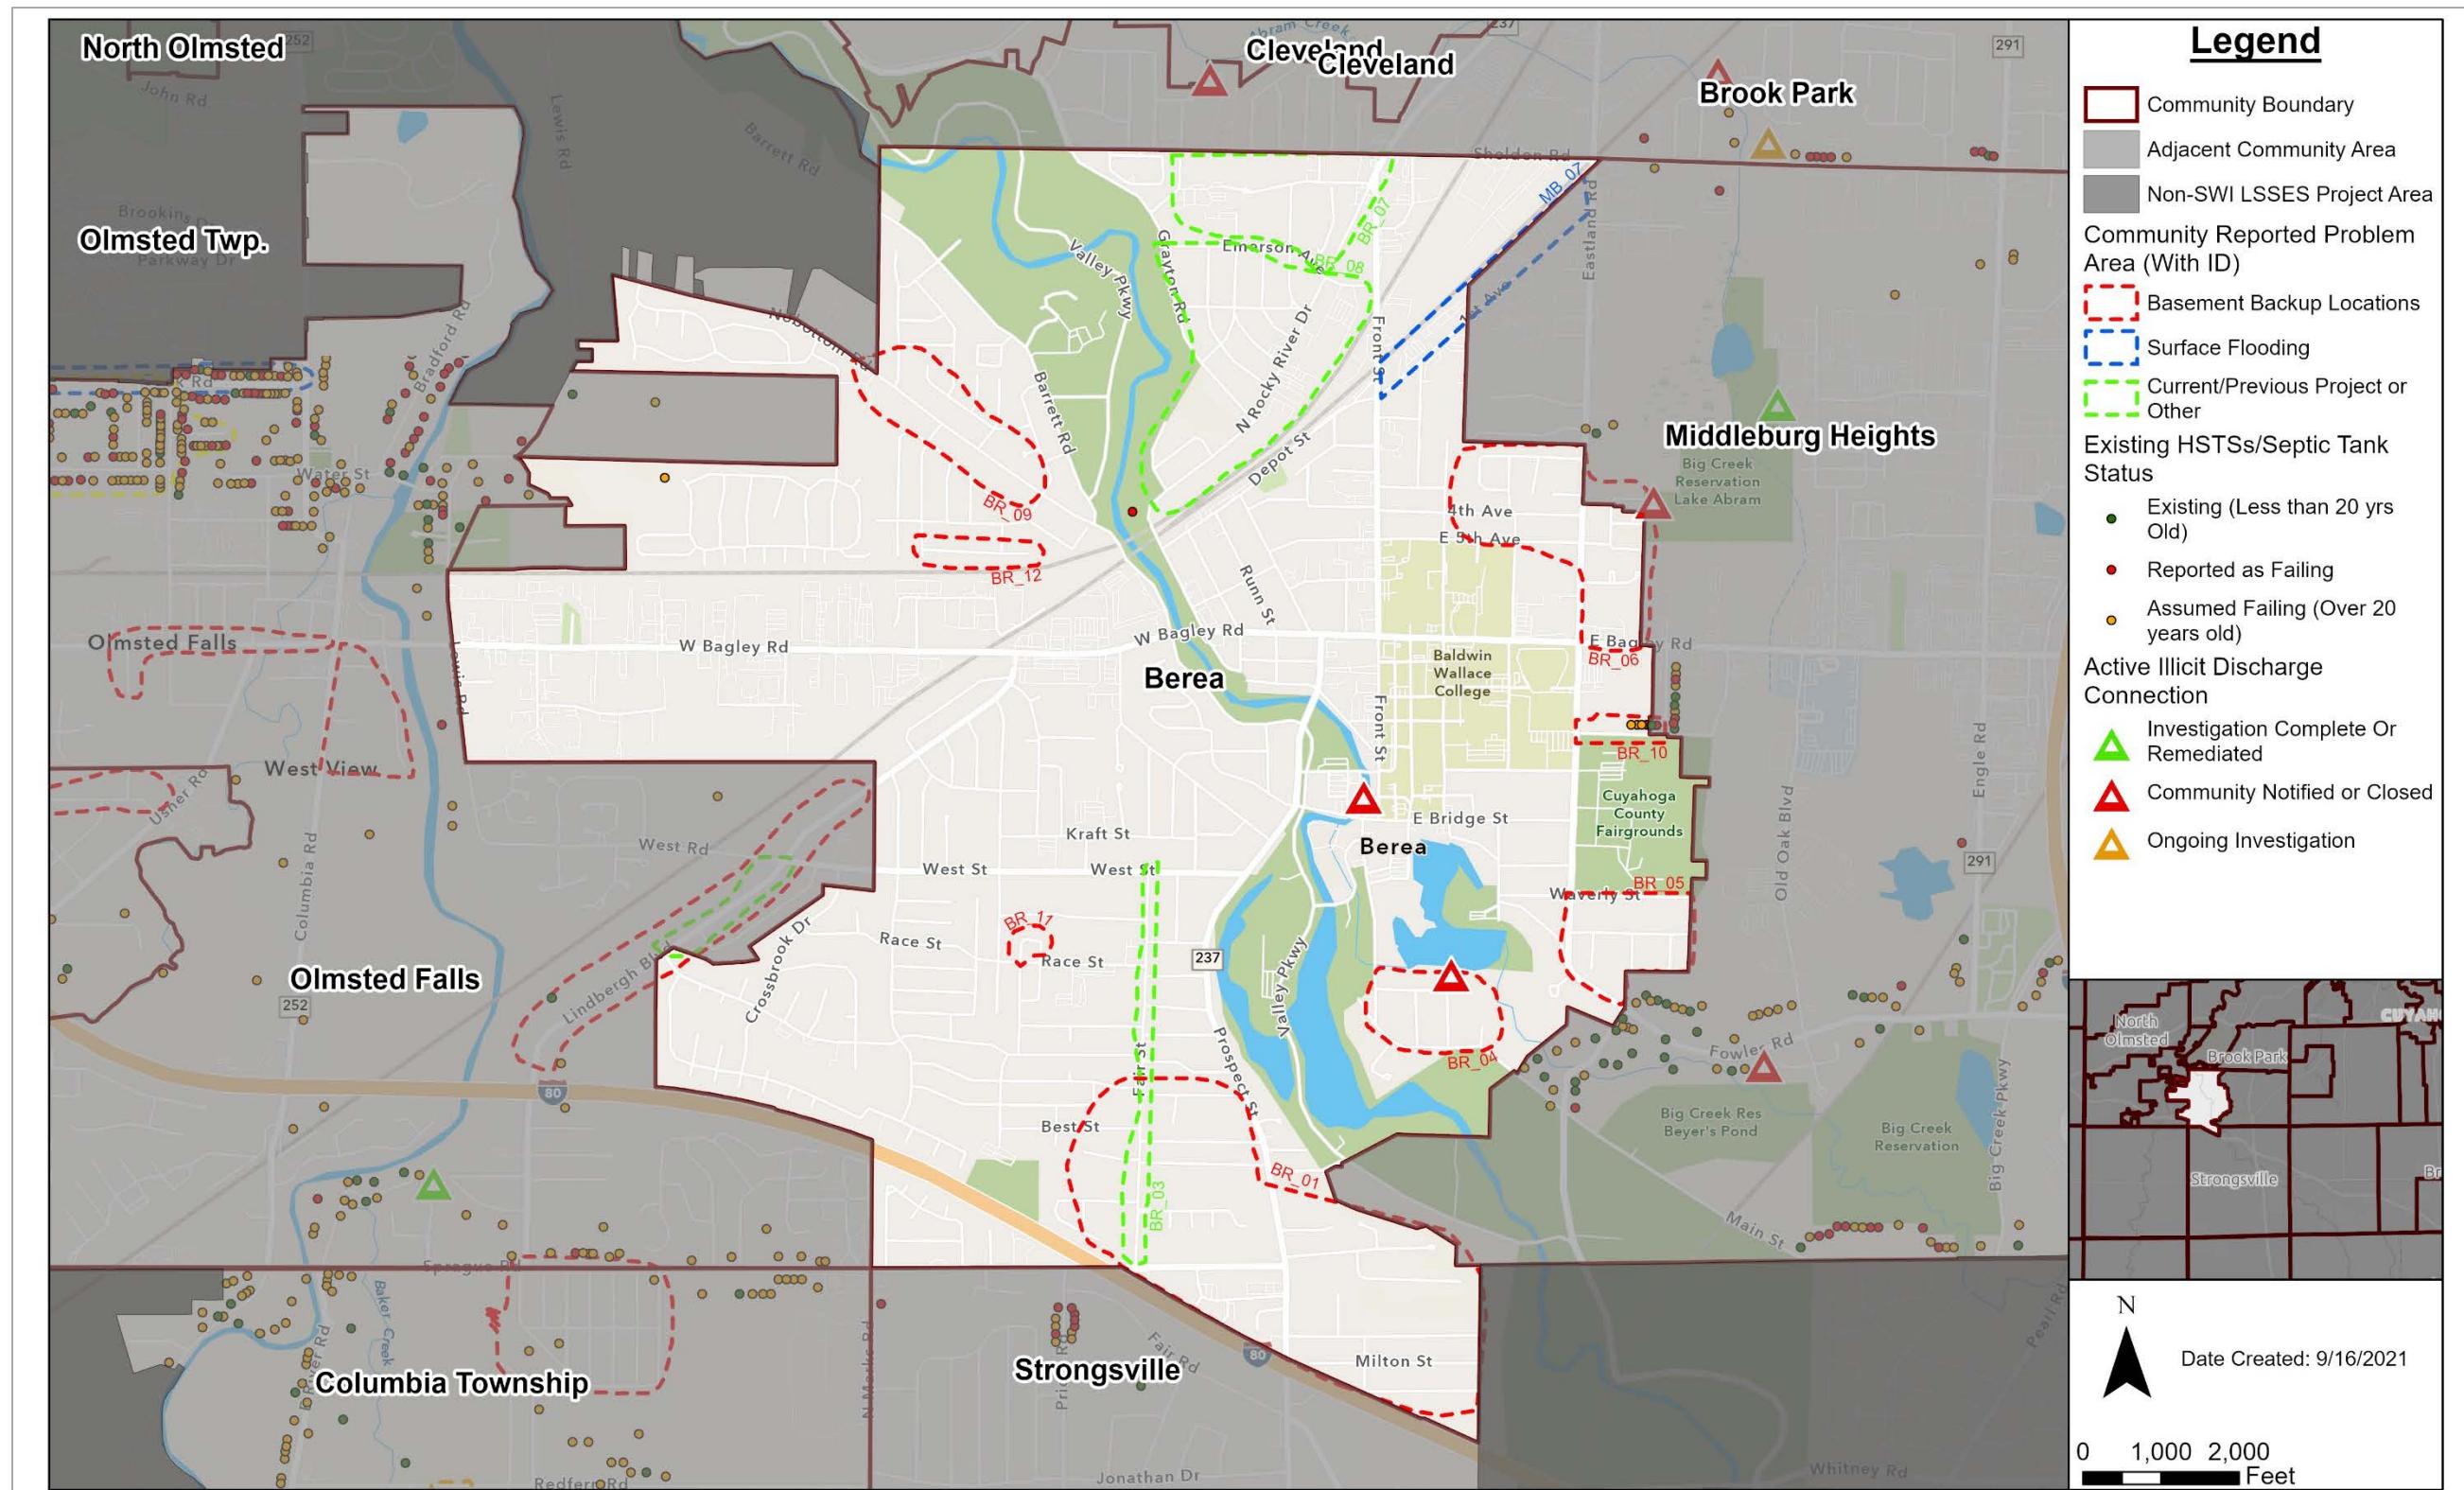
Figure 3-13. Berea IDDE and Failing HSTS Locations

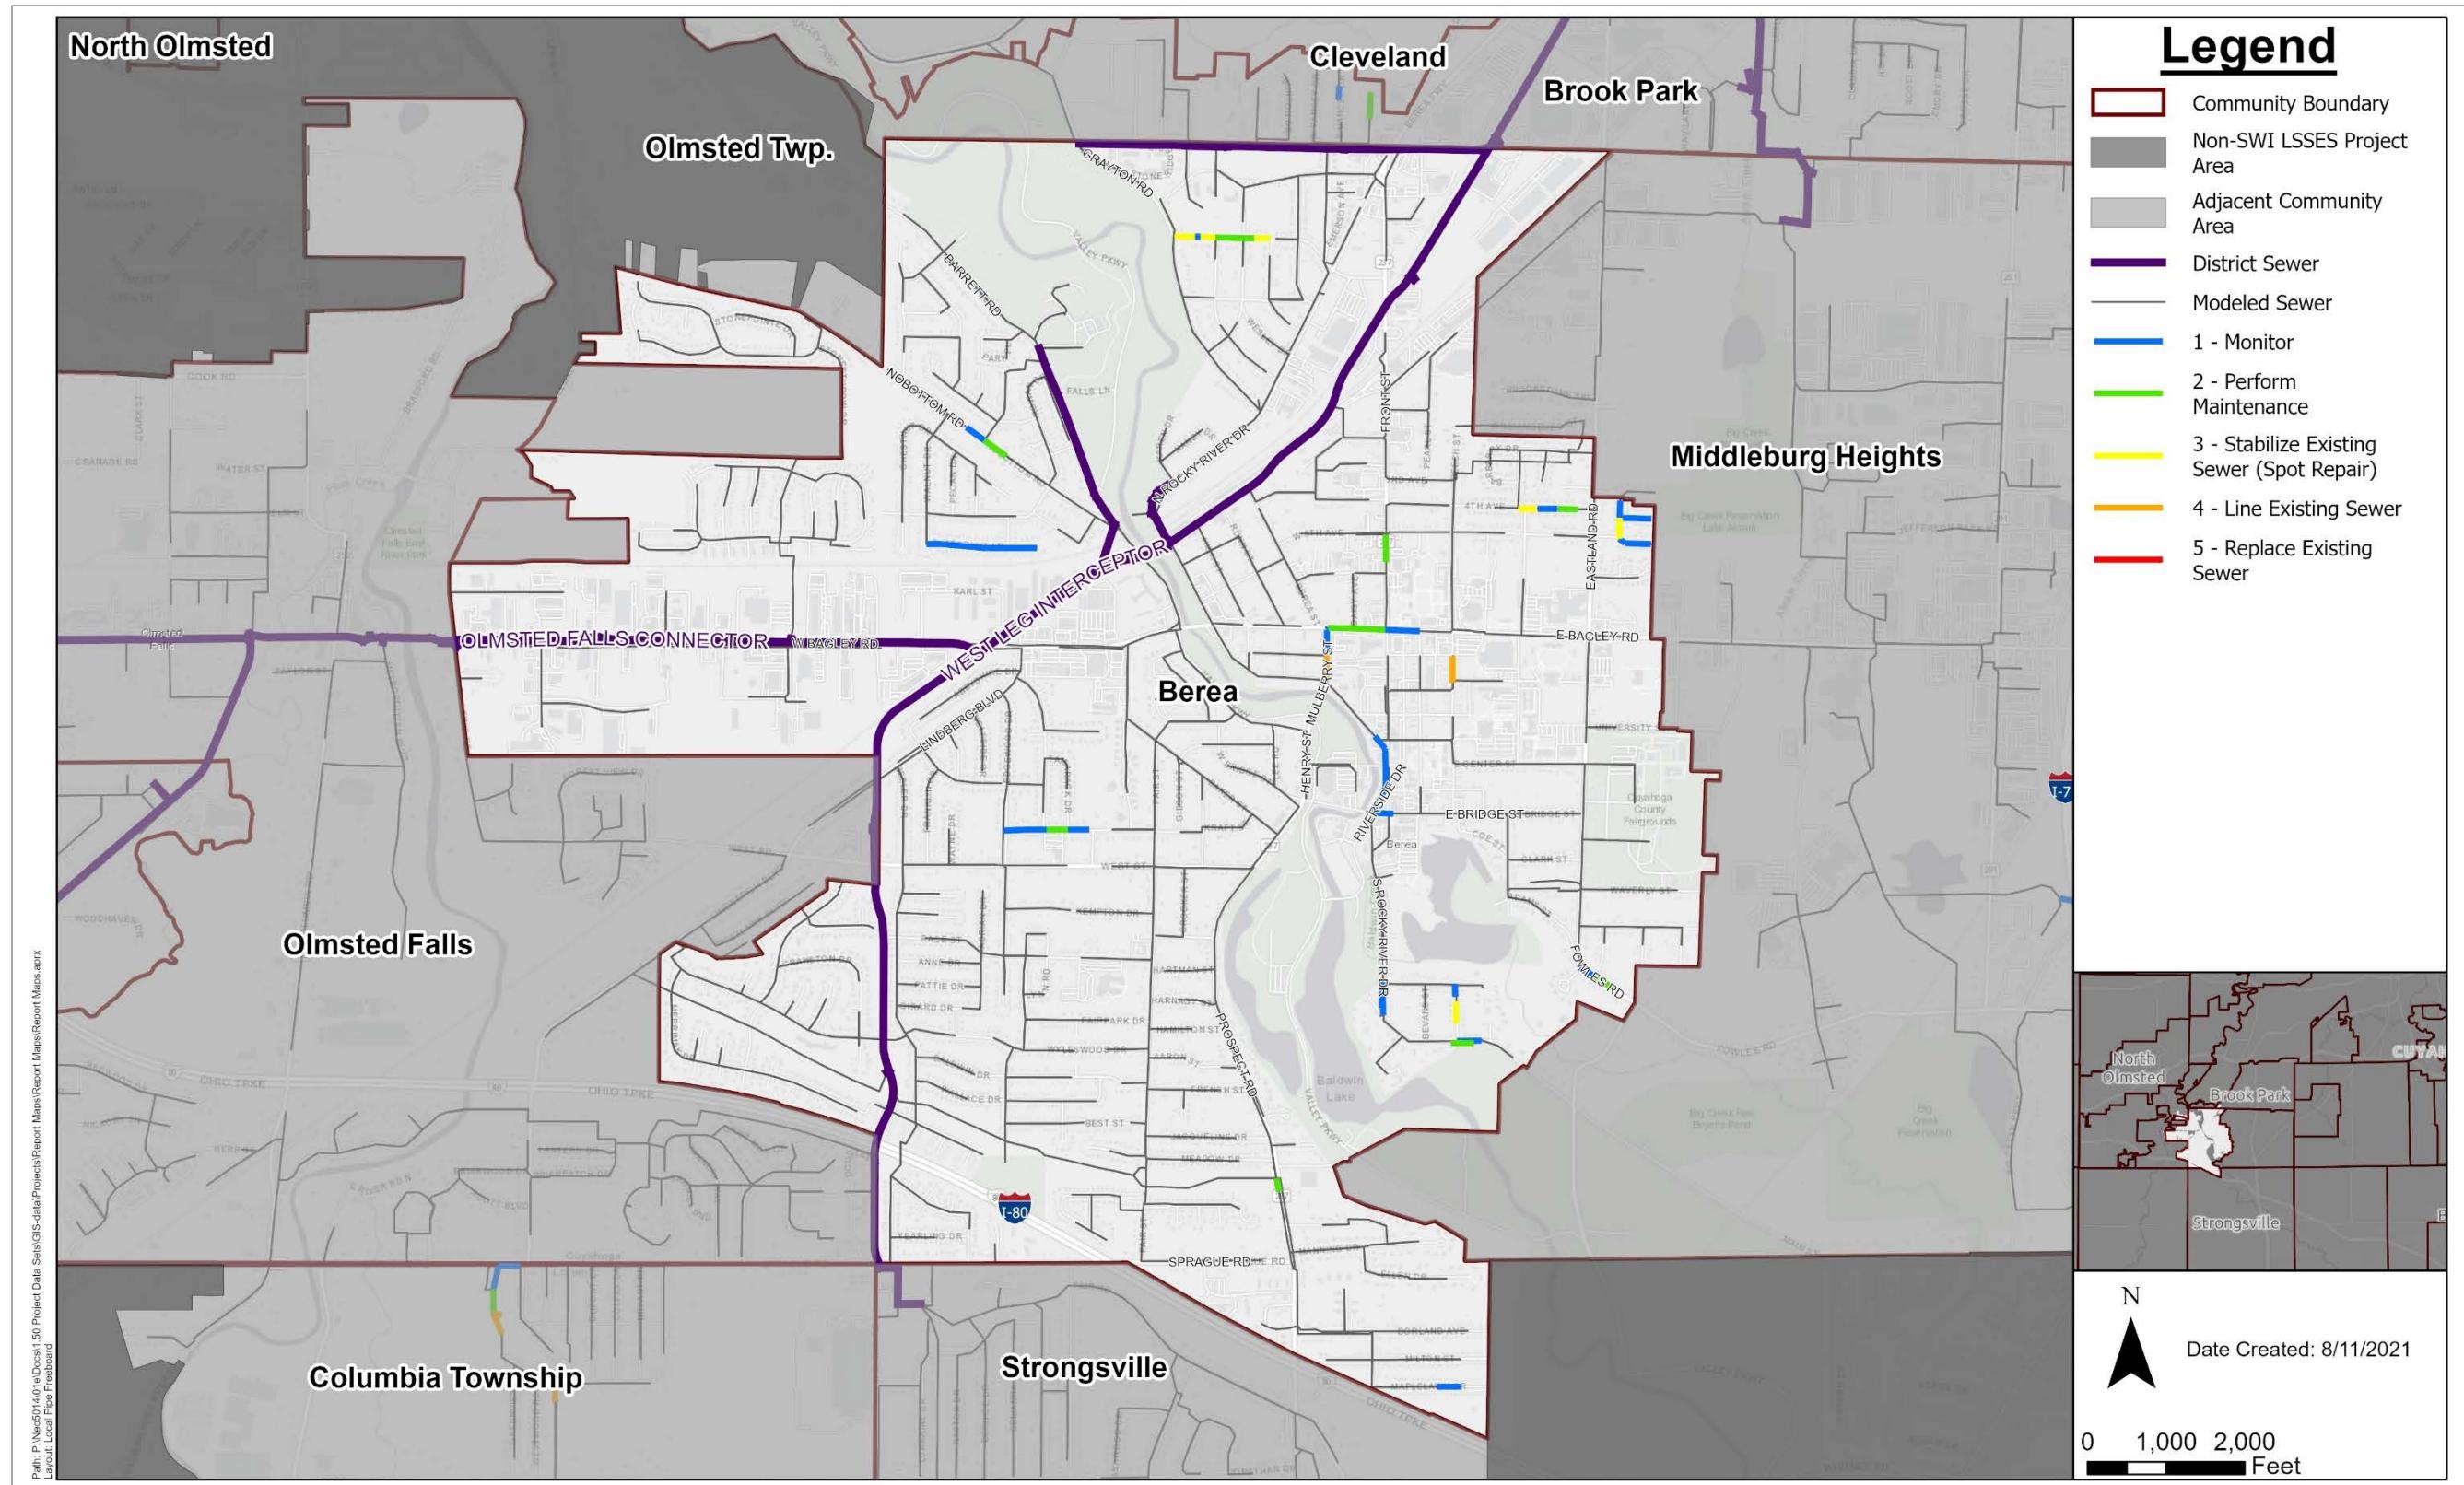
Figure 5-8. Summary of Sewer Rehabilitation Recommendation Levels Based on Project CCTV Inspection
