**Southwest Interceptor
Local Sewer System Evaluation Study
(SWI-LSSES)**

**City of Berea
Community Report**

February 2022

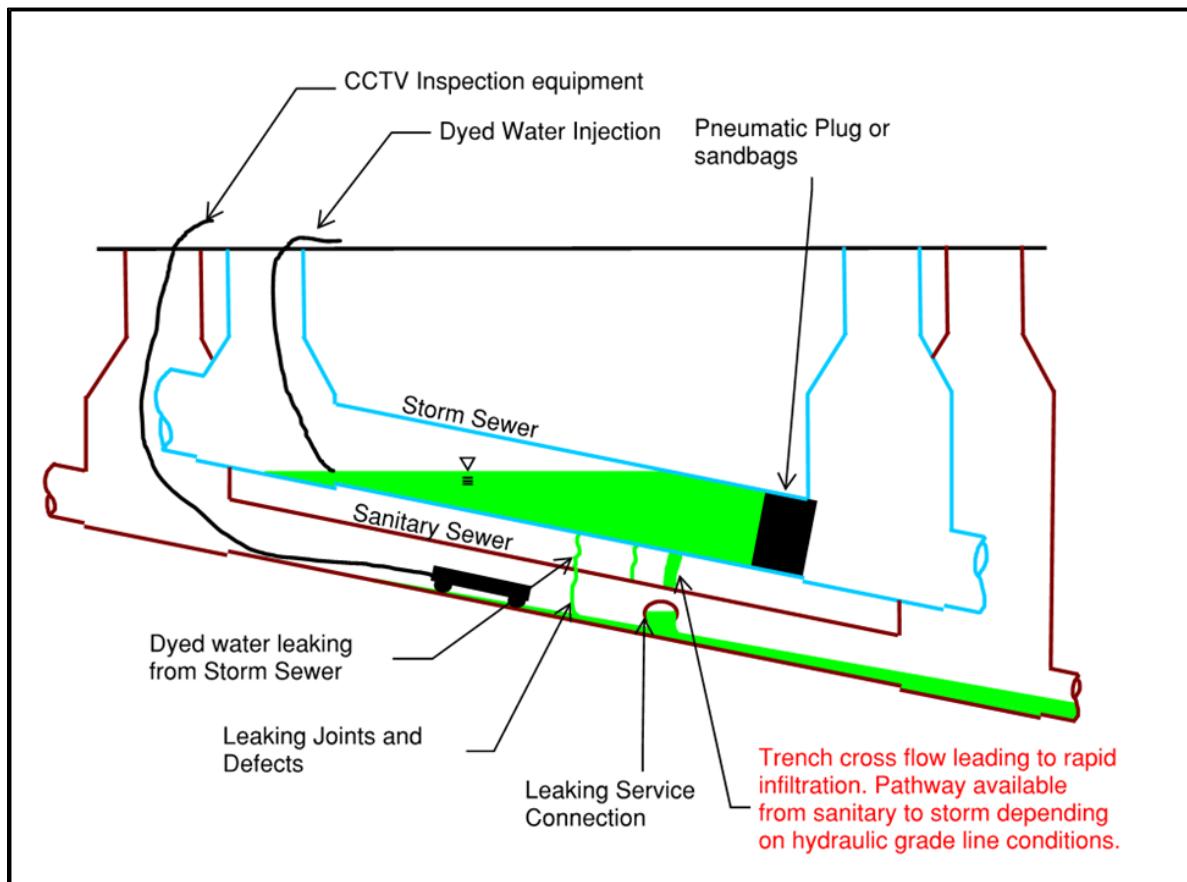
Figure 3-3. Example of Dyed Water Testing Setup

Dyed water testing found significant I/I in both the public ROW sewers, and from private property sources. In Berea, dyed water testing was conducted in 23 sewer reaches totaling approximately 5,550 LF, through Work Order 93. In this length, 25 infiltration defects were found, with five pipe defects classified as rapid infiltration, and one rapid infiltration lateral connection defect. An example of a rapid storm sewer exfiltration/sanitary sewer infiltration is where existing industry standard codes from the National Association of Sewer Service Companies (NASSCO) do not adequately describe the severity of infiltration. Future infiltration reduction efforts should consider addressing these defects as a high priority. **Figure 3-3** provides a sketch of the dyed water testing setup and **Figure 3-4** shows an example service lateral with a high infiltration rate during mainline dyed water testing. **Figure A3 in Appendix A** indicate pipes with positive crossflow infiltration tests highlighted in yellow. This information is also provided in the District's AGOL website for this project.

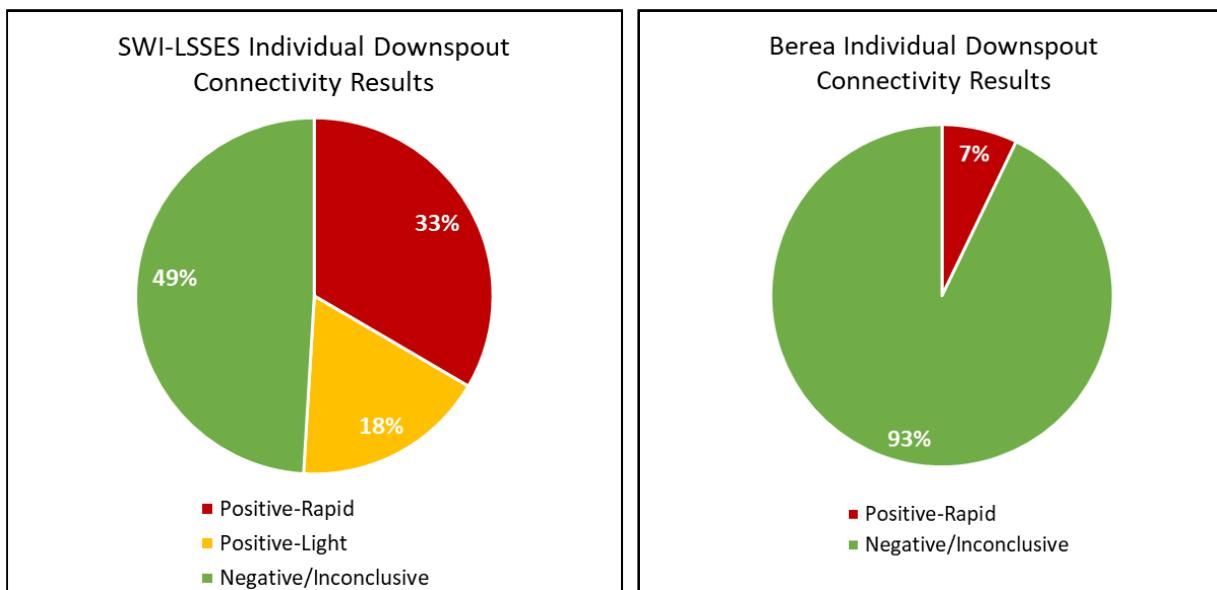
Figure 3-5. Individual Downspout Testing Connectivity Results

Private property I/I sources were tested at more than 400 properties as part of the SWI-LSSES efforts, including 17 properties in Berea. As shown in **Figure 3-5**, across the SWI-LSSES area, 49% of downspout tests did not find dyed water entering the sanitary lateral, 33% showed a rapid response during dyed water testing, and 18% showed a delayed/light response. A rapid response may be attributed to a direct connection or significant defects in the underground downspout plumbing or laterals. Slower responses may be attributed to minor defects in plumbing. In Berea, 7% of the downspouts tested were observed with a positive-rapid response, which is approximately 26% lower than the rest of the tests completed for the SWI-LSSES area.

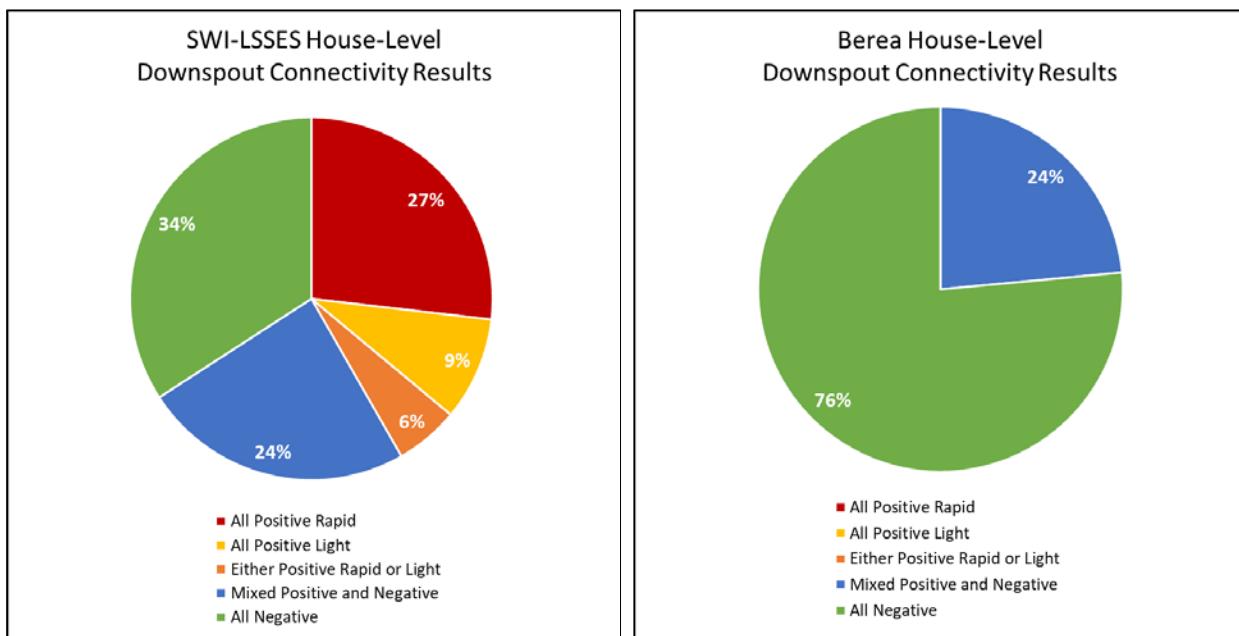
Figure 3-6. House-Level Downspout Testing Results

Results were also assessed at the house level. Most houses have multiple downspouts. The house level assessment indicates the percentage of houses that have at least one positive downspout test. Testing completed for the SWI-LSSES found no evidence of dyed water in the sanitary lateral at 34% of houses, and the other 66% had some dye transfer. In Berea, 76% of houses had no evidence of dyed water and the remaining 24% had some transfer as shown in **Figure 3-6**. In Berea, no residences tested had every downspout show a positive dyed water response in the sanitary sewer. The typical test setup utilizes a CCTV camera to monitor the sanitary sewer service connection for dyed water.

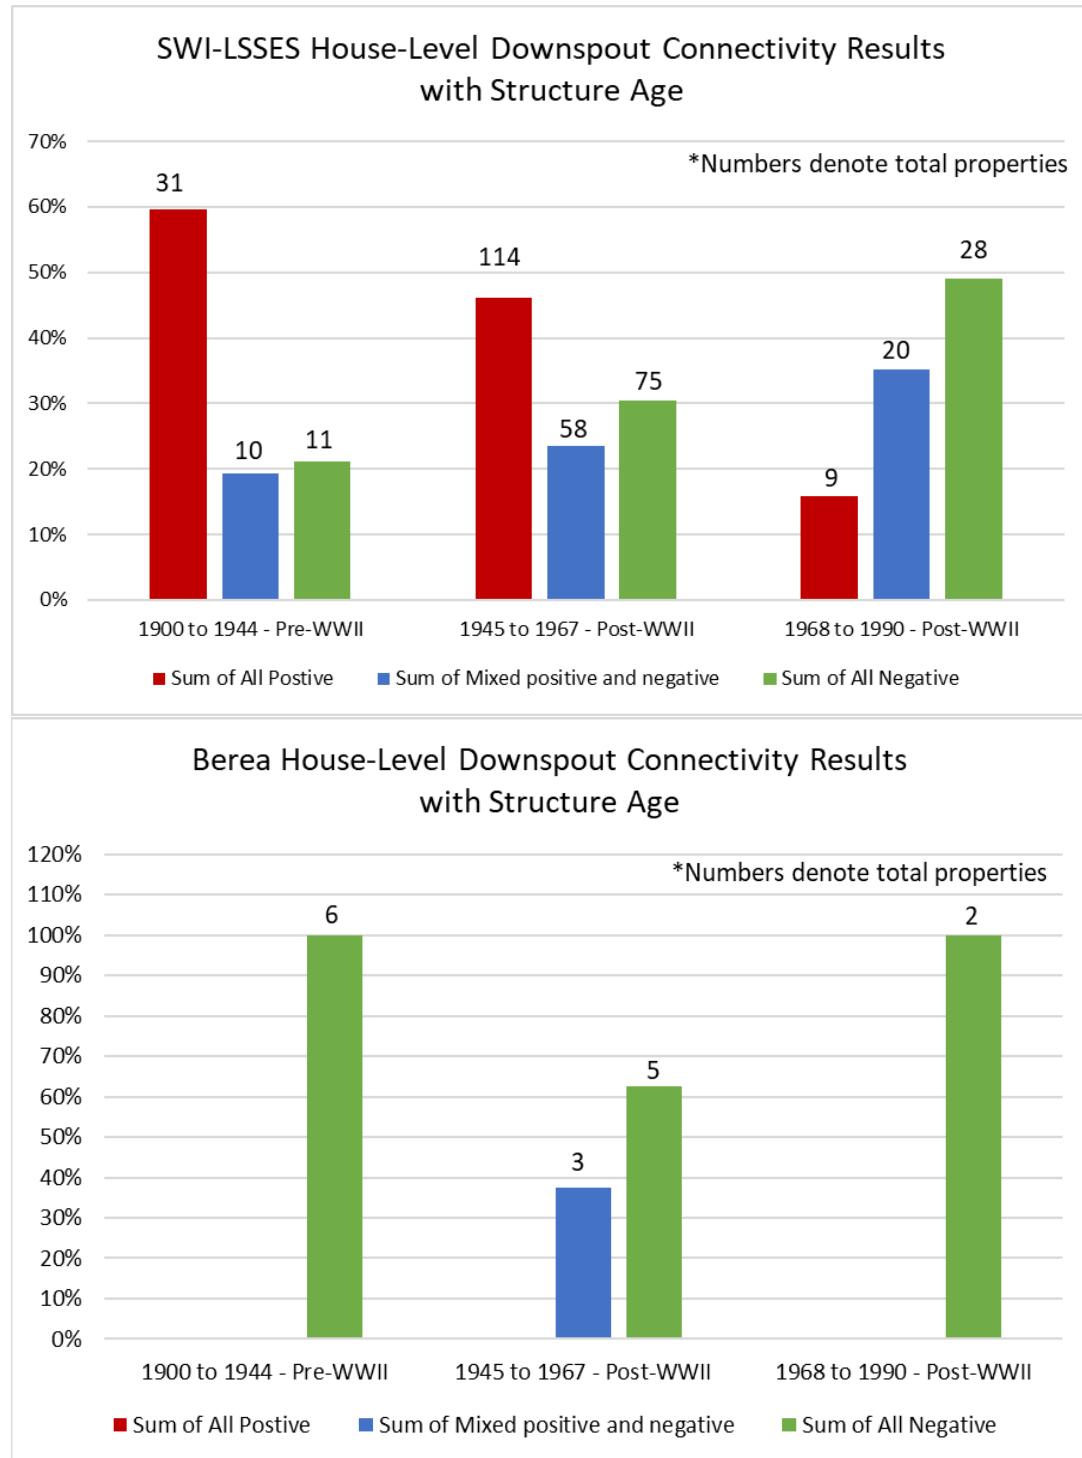
Figure 3-7. Downspout Test Results with Structure Age (SWI-LSSES and Berea)

Private property investigations were also compared against building age for the study area. Approximately 67% of buildings tested throughout the study area were constructed between 1945 and 1967 (post-WWII). The other buildings that were tested were constructed in the 1800s (<1%), between 1900 and 1944 (14%, pre-WWII), between 1968 and 1990 (15%, post-WWII), and post-1990 (3%). The results presented in **Figure 3-7** show that SWI-LSSES buildings constructed between 1900 and 1944 (pre-WWII) had more positive I/I tests than other eras. It is unknown whether this is due strictly to age/deterioration of the piping, or if materials and/or construction methods vary significantly during the different periods. Unlike the overall SWI-LSSES area, buildings in Berea that were constructed between 1945 and 1967 (post-WWII) had more positive I/I tests (mixed positive and negative) compared to those constructed in other eras. **Figure 3-7** does not show test results for one home in the study area (and Berea) that was built in the 1800s (mixed positive and negative) or 12 homes tested that were constructed after 1990 (all negative).

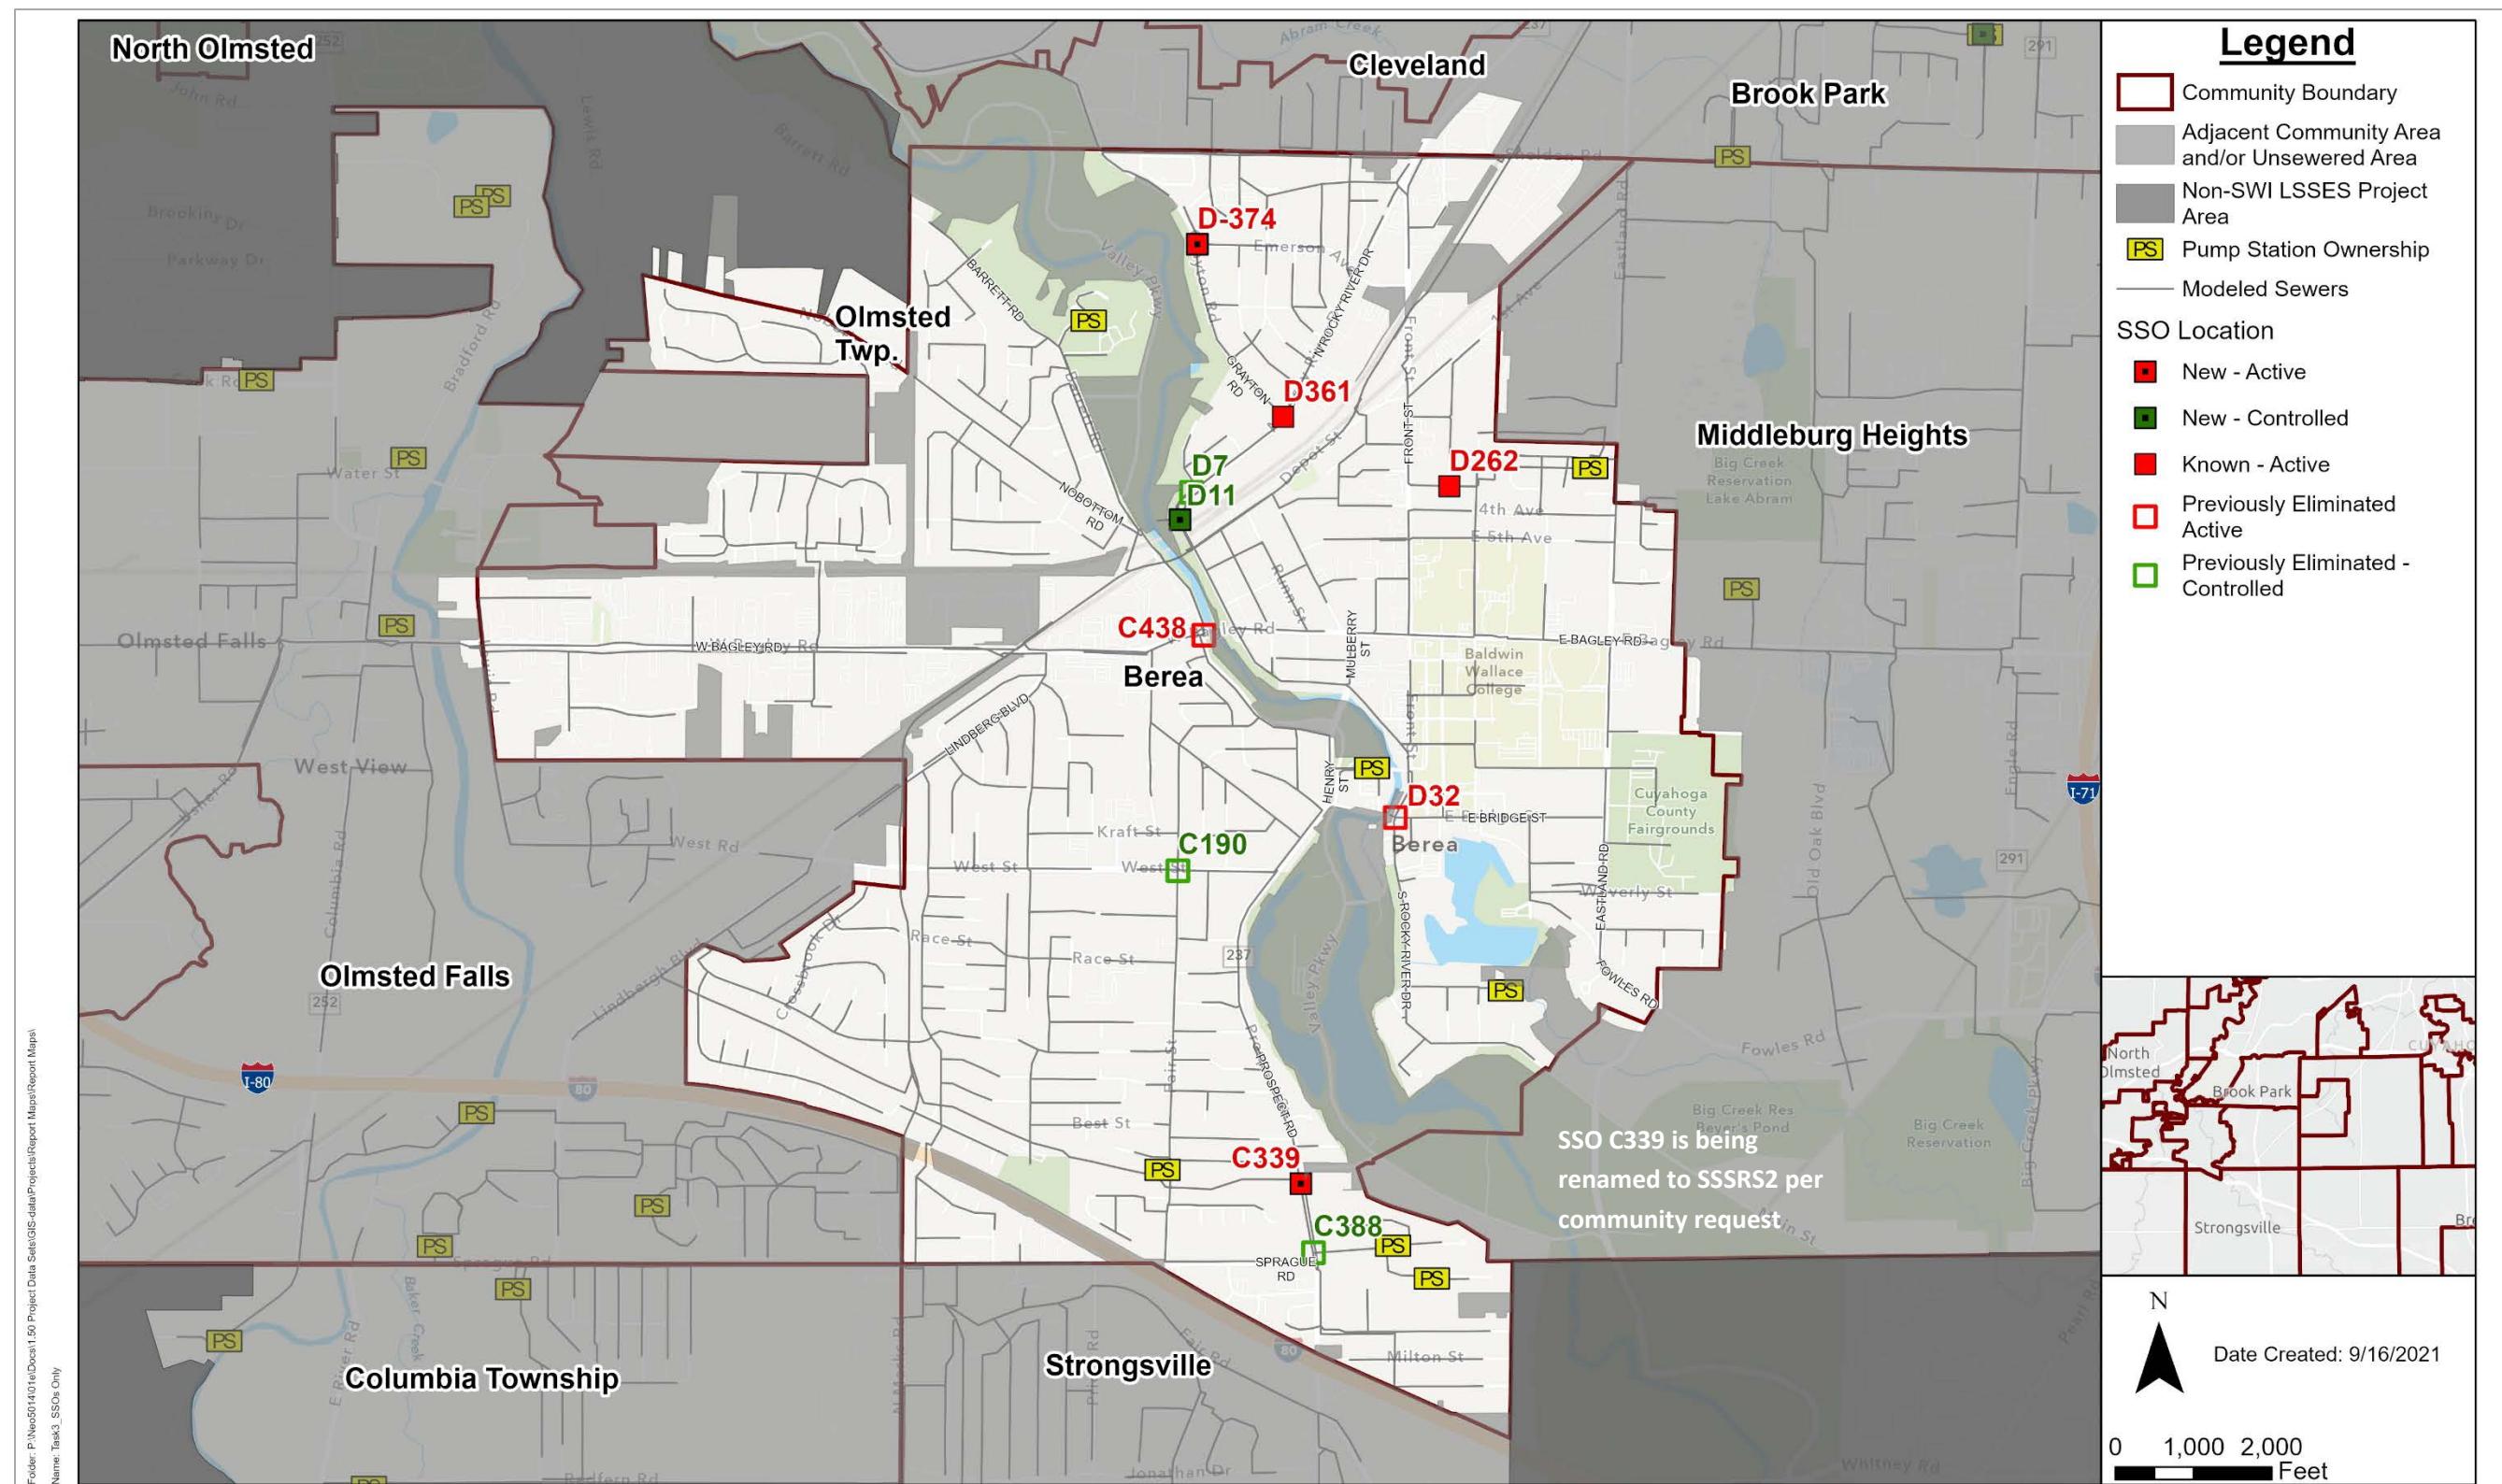
Figure 3-12. Modeled SSOs Projected Status – 5-Year, 1-Hour Rainfall

Figures 3-10 and 3-11 summarize the projected Berea sanitary sewer system routed flows for the 5-year, 1-hour rainfall using GPAD and GPDIM for each PFA based on the calibrated events. For rainfalls larger than the calibration events, limited sewer system capacity may reduce the peak rate measured in the system. **Figure 3-12** shows the locations and control status of the known SSOs in Berea (5-year, 1-hour rainfall).

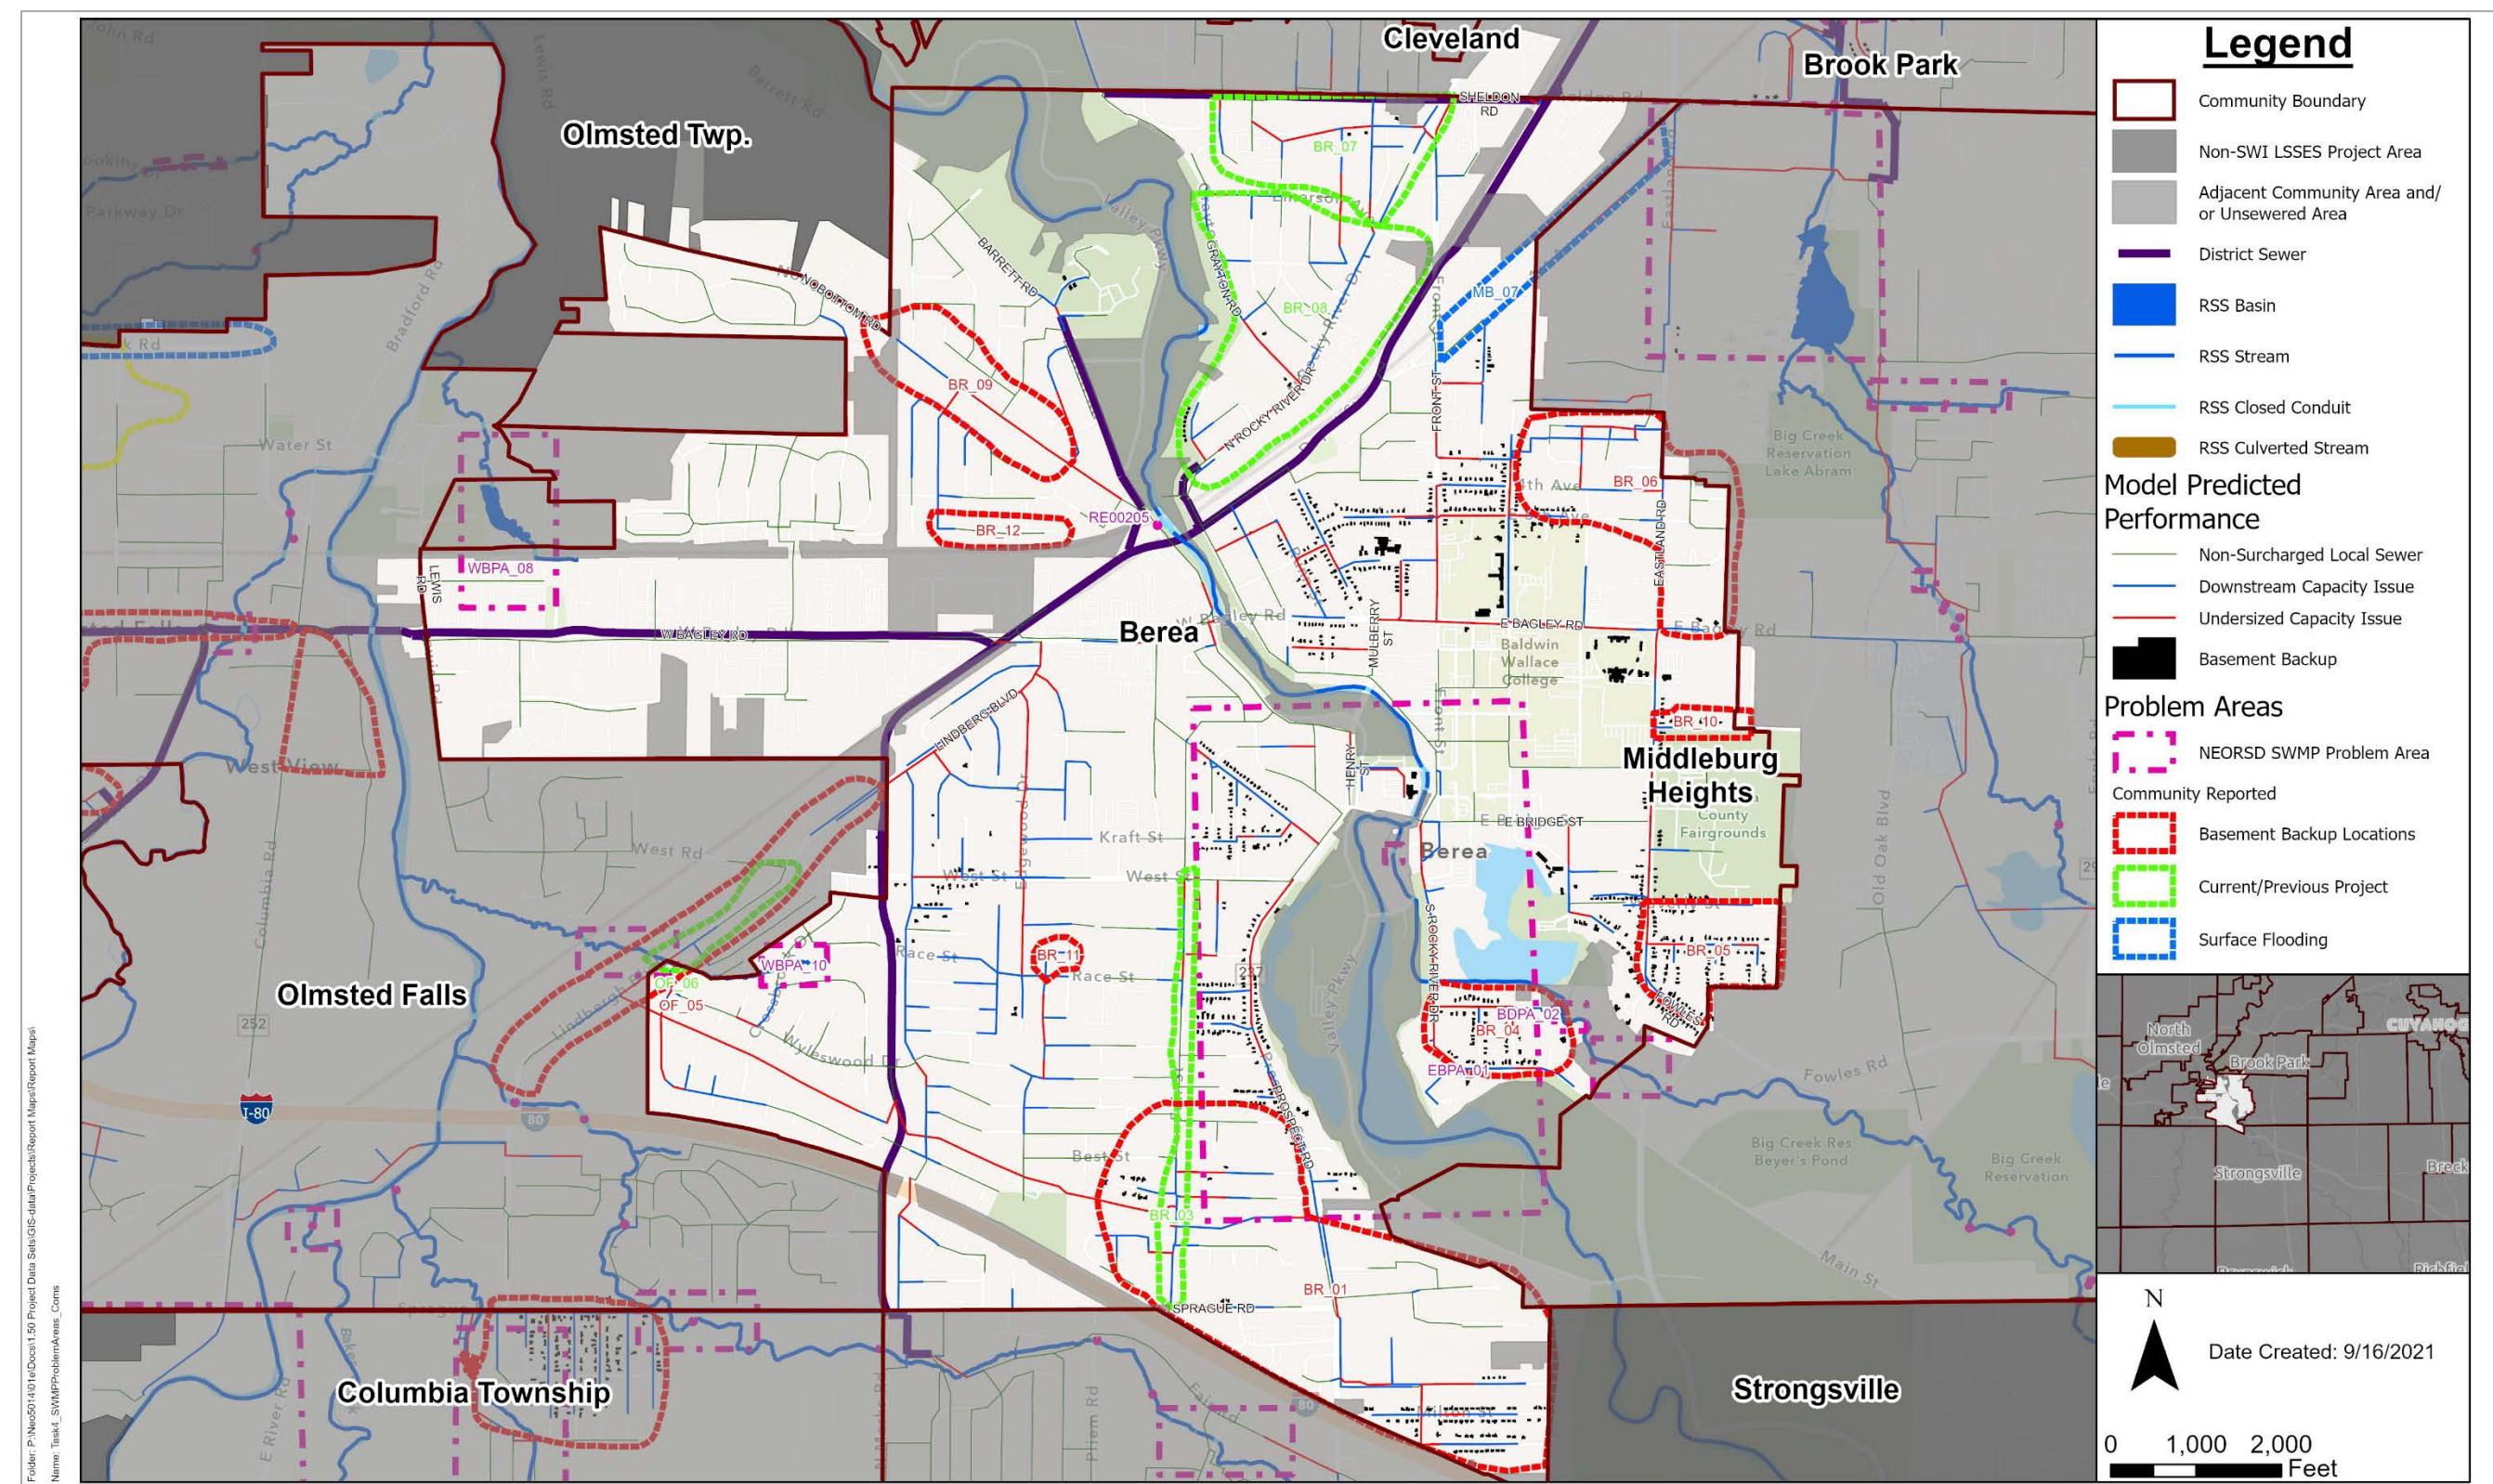
Figure 3-14. SWI-LSSES Projected Problems Near District SWMP Problem Areas

Berea reported 8 recurring BBU areas listed previously in **Table 2-1** and shown in **Figure 3-14**. Throughout the SWI-LSSES area, the reported problems often agree with other sources of information and analysis to help confirm the problems identified. In some instances, the analysis has projected performance problems where none have been reported, or the reported problems are not substantiated by the calibrated model projections. These inconsistencies likely arise from the approximate nature of the sewer system model, particularly in common trench areas, where the numerous sanitary/storm sewer crossflows and parallel storm sewers are not being explicitly modeled. Communities may wish to update the problem areas if additional reports are received by providing updated information to the District watershed team leader.

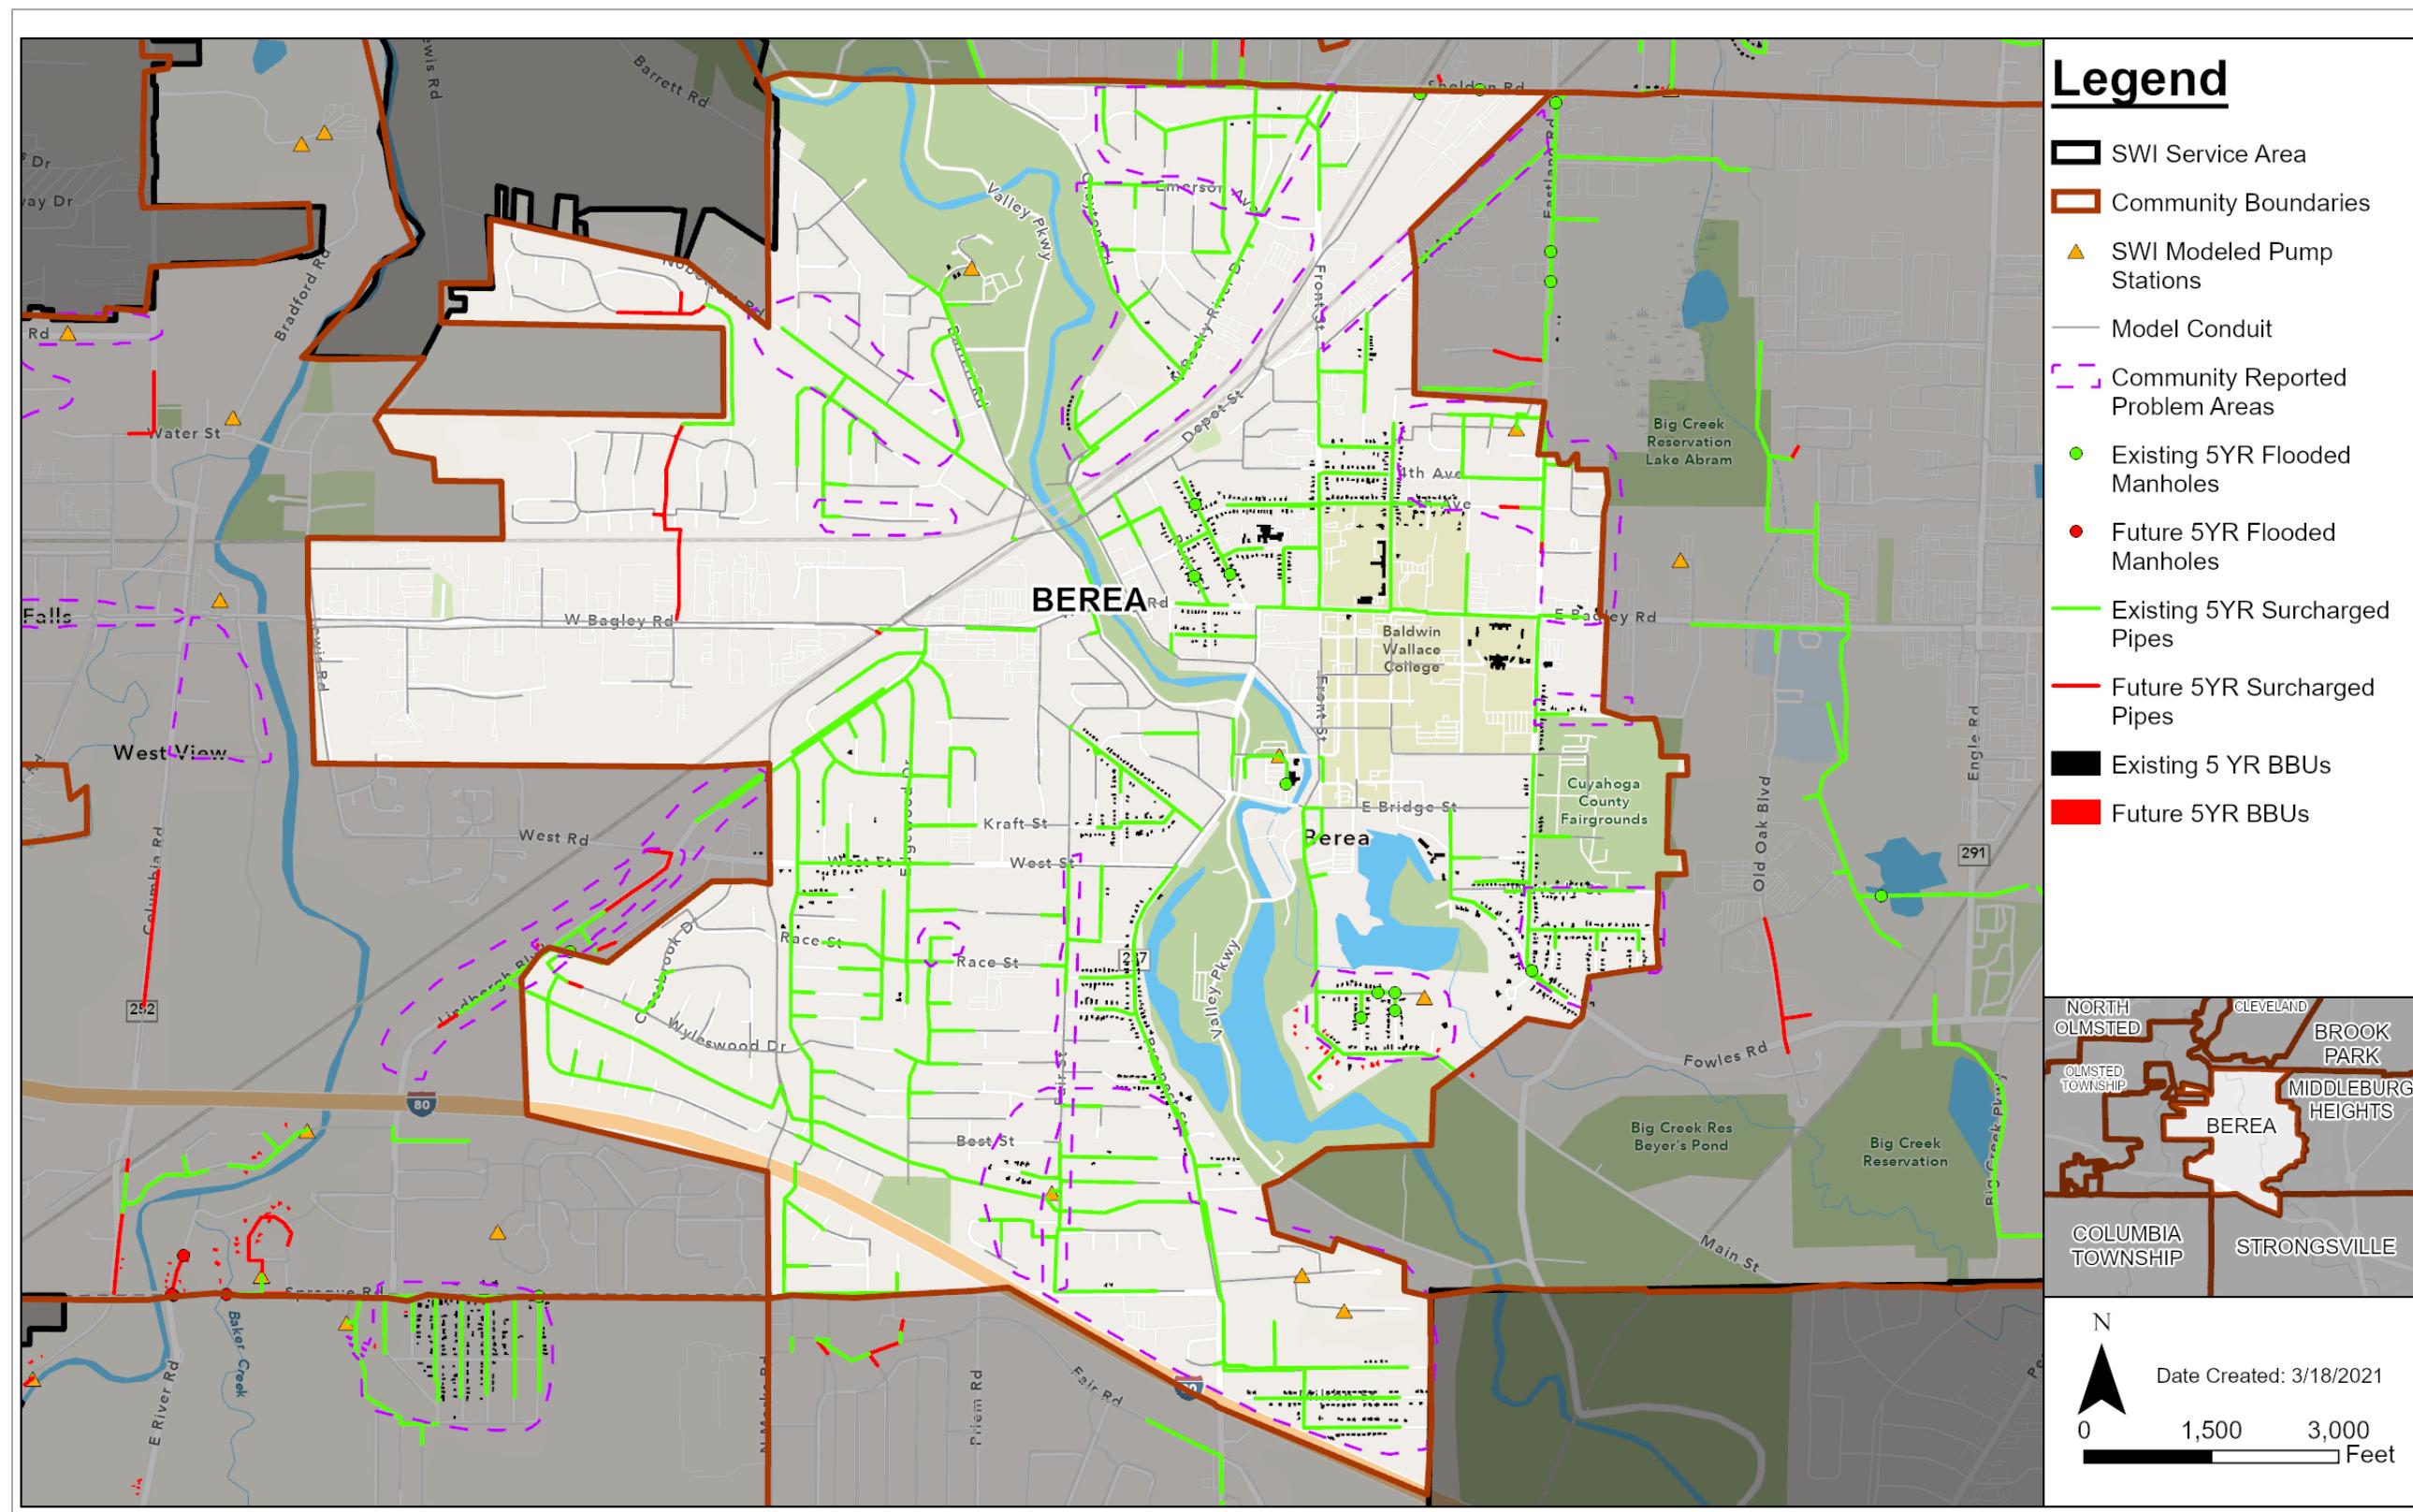
Figure 5-19. Existing Versus Future Conditions Base Model Results

Areas shown in **Figure 5-18** were added to the base (existing) system model, assigned the estimated dry and wet weather flow parameters, and connected to the nearest modeled node. Existing and future development conditions were then run for the 5-year, 1-hour design event for three models: base system condition with no improvements, base system model with Tier 1 improvements, and base system model with Tier 1, Tier 2, and Tier 3 improvements. **Figure 5-19** shows the existing conditions versus the future conditions base system model results, and **Table 5-13** summarizes the results for all three models. Results for the Tier 1 improvements model and the Tiers 1-3 improvements model are provided in **Appendix H**. A summary report was also developed for the SWI-LSSES future conditions analysis and is available from the District upon request.

The developed Tier 1, 2, and 3 improvements were not adjusted based on the future conditions modeling results. This should be considered during design of improvements to address hydraulic issues in problem areas.

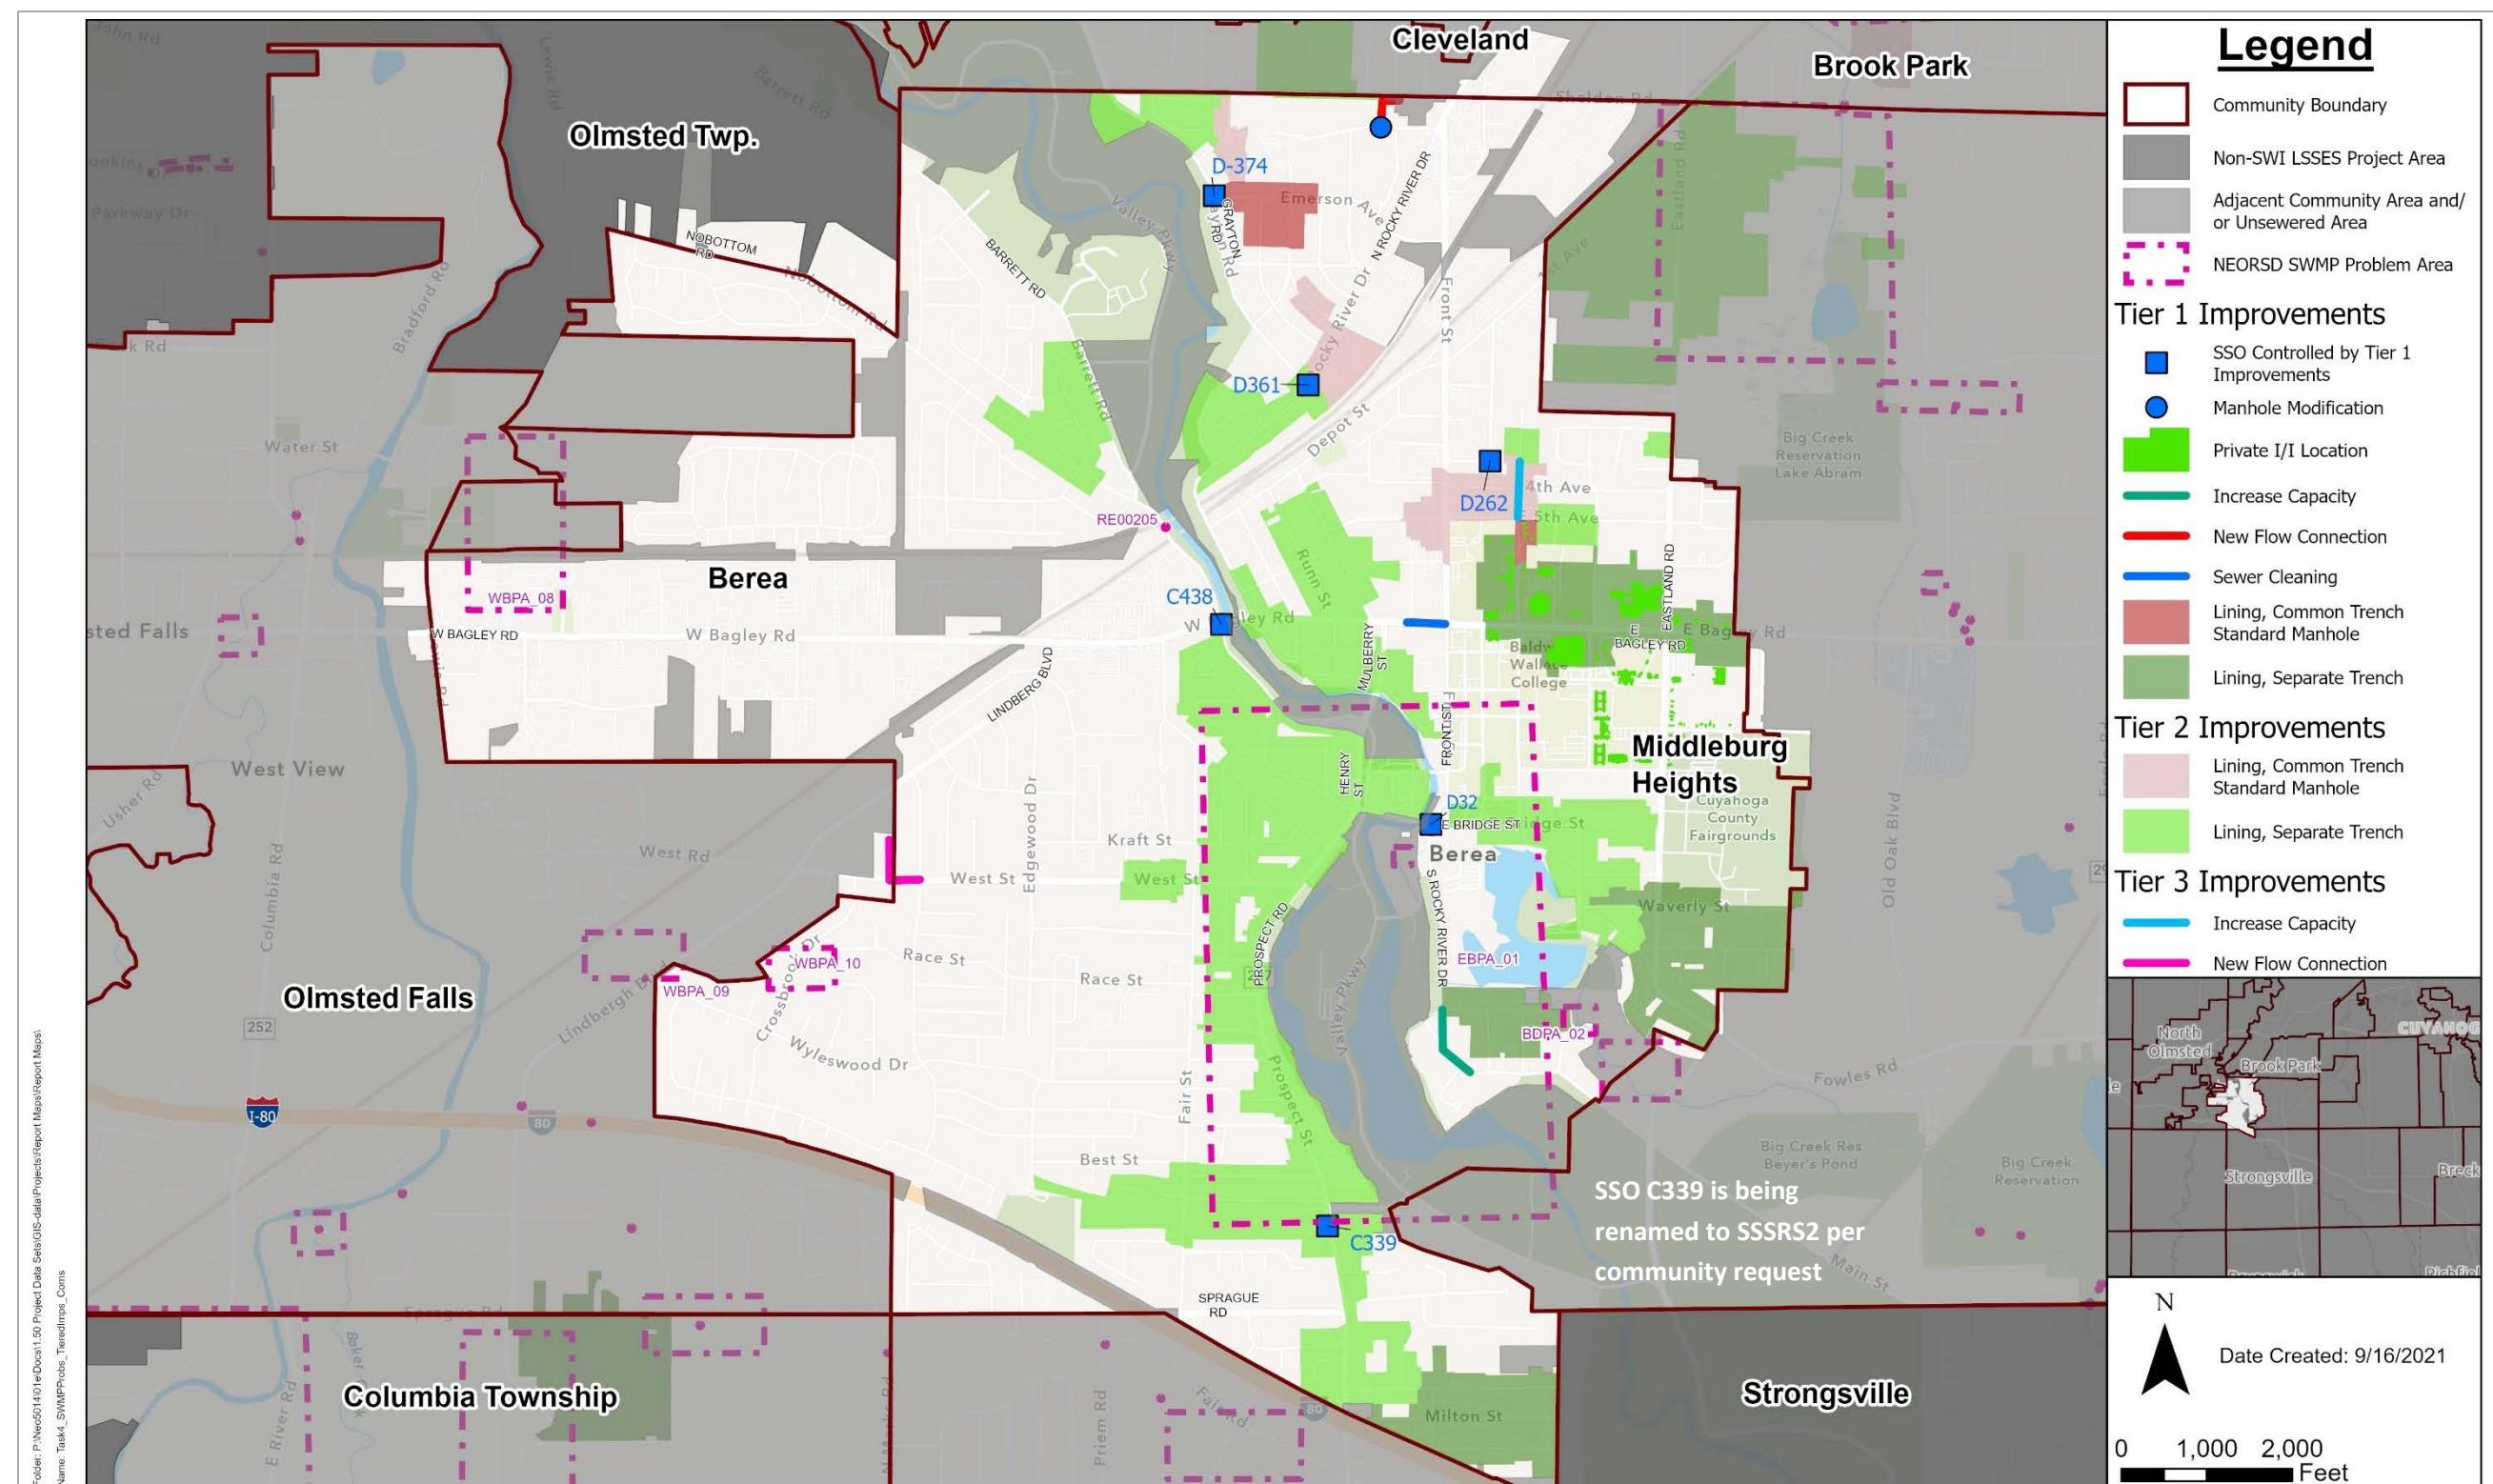
Figure 7-1. LSSES Recommended Improvements Near District SWMP Problem Areas

The SWI-LSSES project identified SWMP problem areas with respect to where potential opportunities may exist for coordinated sanitary and storm projects that could be considered by the community. These overlapping locations indicate areas where additional investigation of storm sewer related problems may be impacting the sanitary system if the storm sewer and/or sanitary systems are not relatively watertight. **Figure 7-1** provides an overview of the SWMP identified problem areas with the recommended LSSES tiered improvements. More detailed information on specific collected data, identified problems and the potential recommended projects from the SWMP is available from the District Watershed Team Leader.
